Ecological Status of Durowskie Lake

Macrophytes

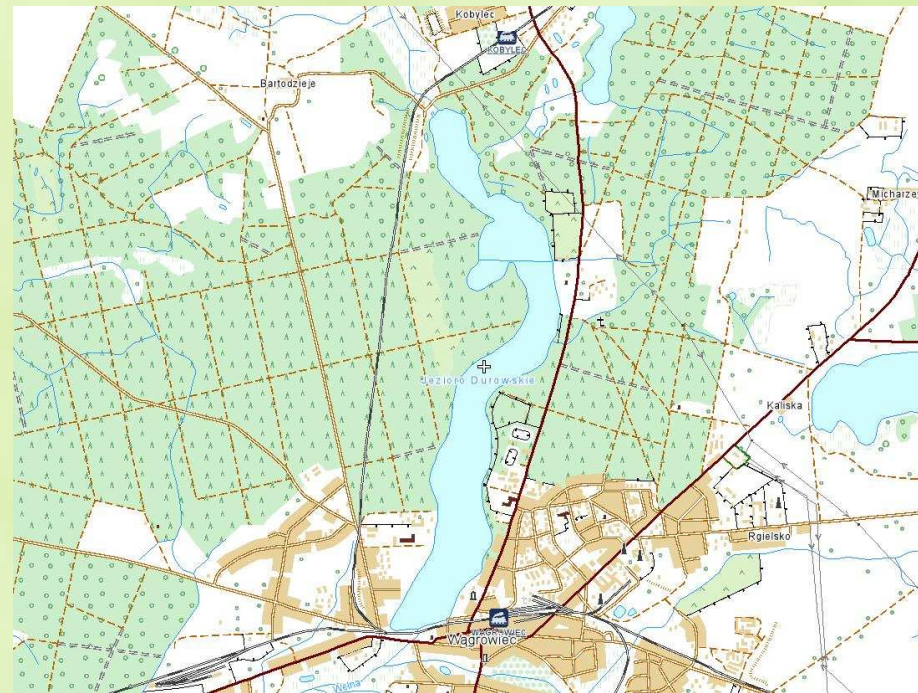
Ryc 1.- Demonstrative map of Durowskie Lake

- Durowskie Lake is post-glacial water body. The lake is elongated in north-south direction.

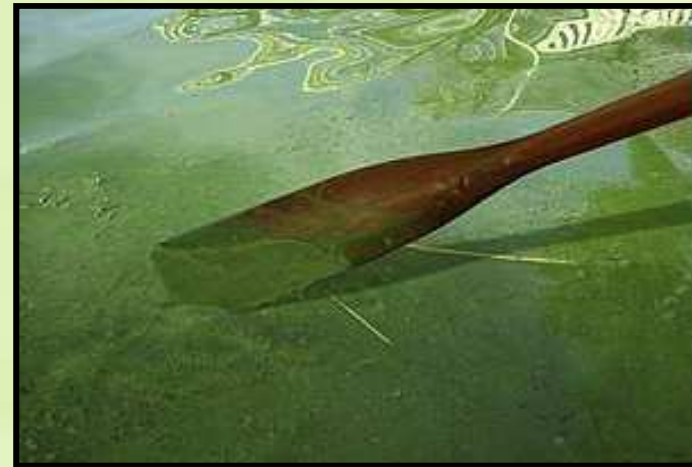
Ryc. 2- The example of algal blooms.

- The Durowskie Lake is ranged into the grup of pollution lakes. The lake is used for tourism and fishing purposes.

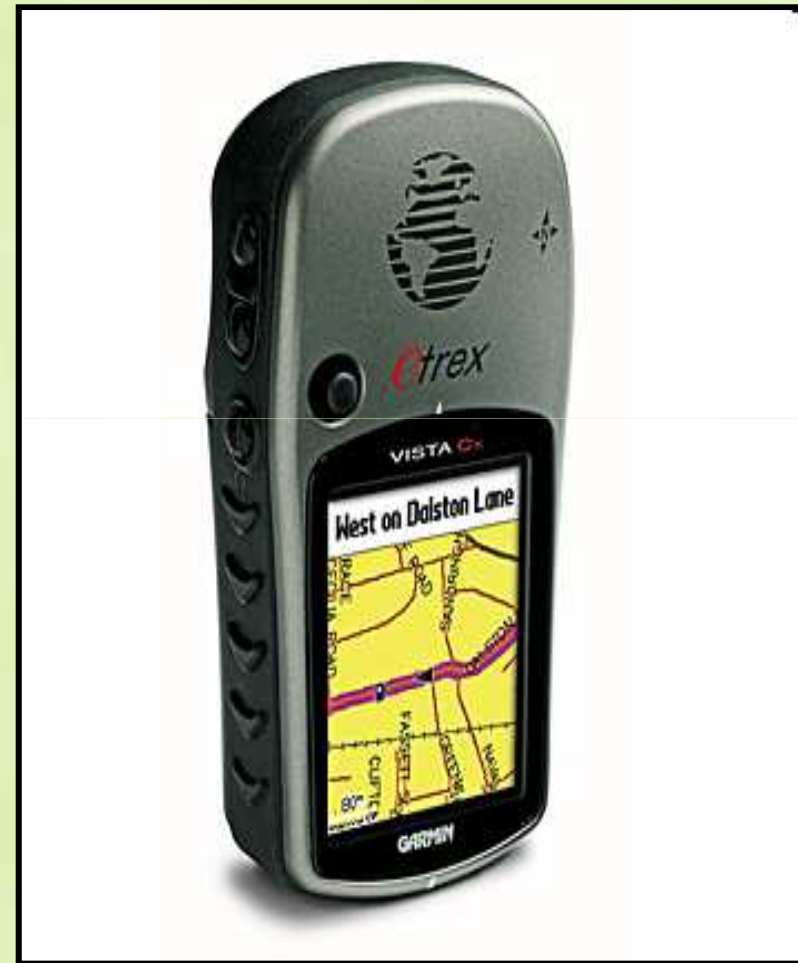
Ryc 3.- exemplary GPS of Garmin brand

- The Geographical position was localized by GPS GARMIN Vista. The results has been elaborated in **Google Earth** software.

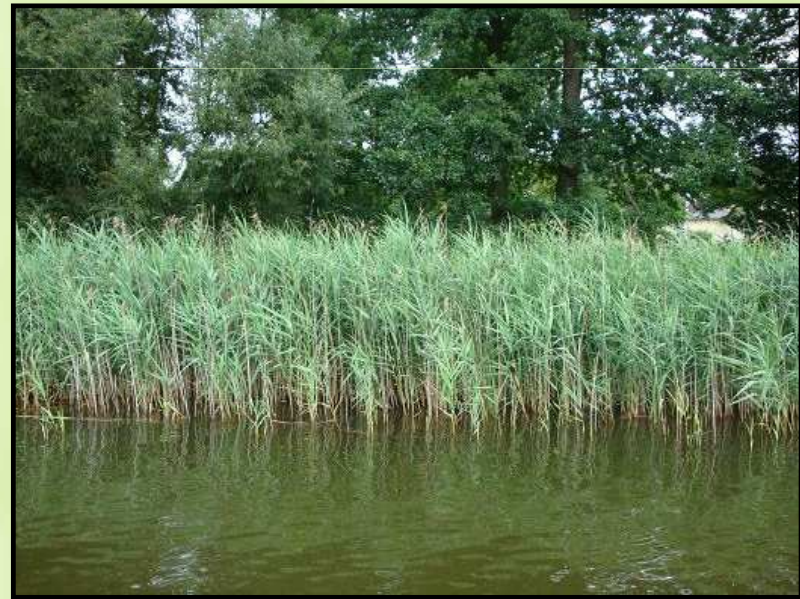
The most frequently observed association in Durowskie Lake (**62%**) is *Phragmitetum communis*.

This association is the most popular in eutrophic lakes

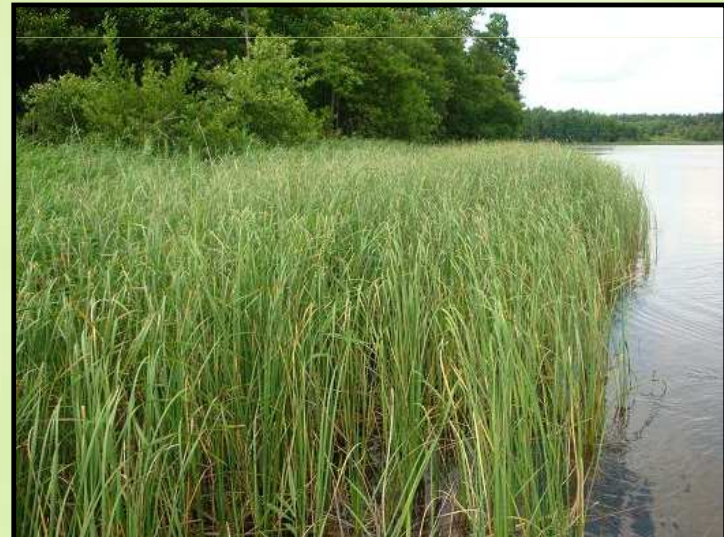
The second association is *Typhetum angustifoliae* (27,25%).

This association is observed in stagnant water bodies or in slow flowed rivers

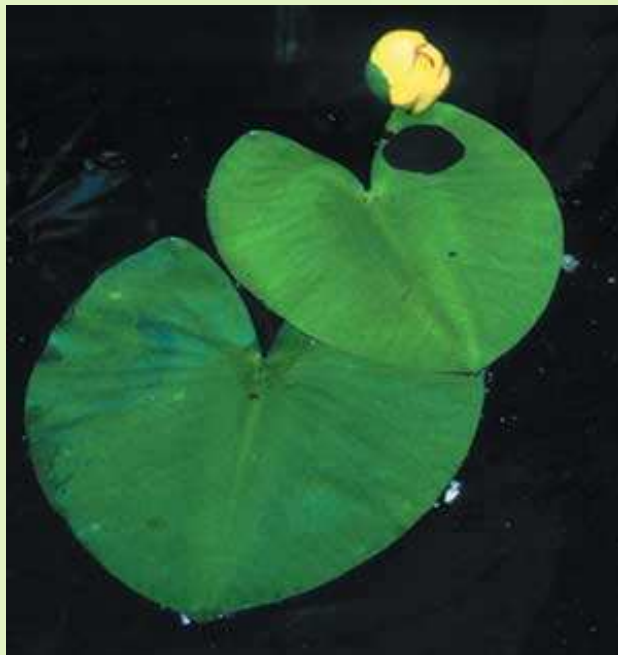
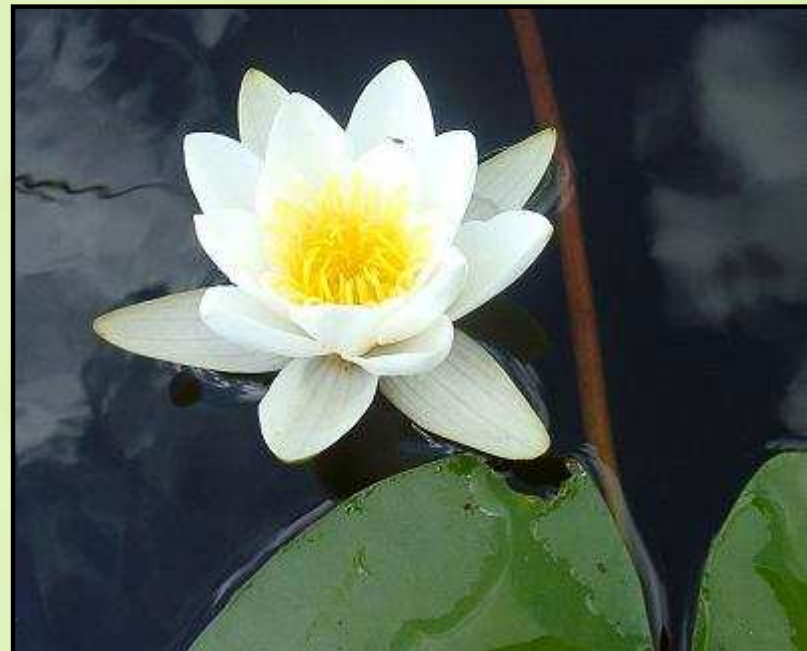
The last dominant association is *Nupharo-Nymphaeetum albae* (3,92%).

The main species of this macrophyte group are the aquatic plants with floating leaves - *Nuphar lutea* and *Nymphaea alba*.

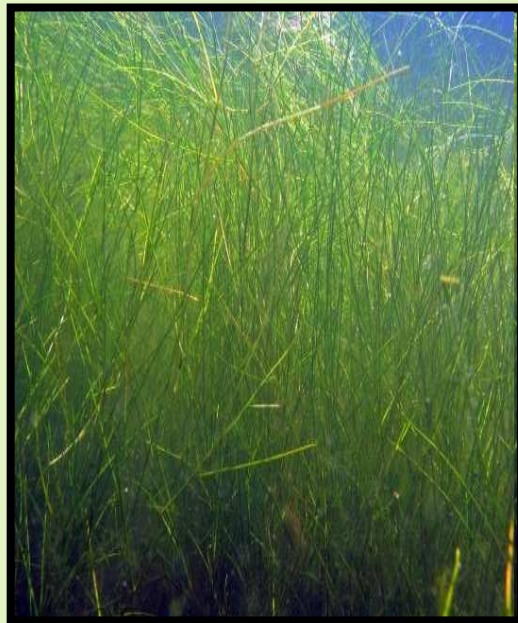
Potamogeton pectinatus

- We should pay a special attention to the **submerged plants**. They are competing with phytoplankton for sun, space and nutrients.
- According to this year research - we have **two new** associations of submerged plants.

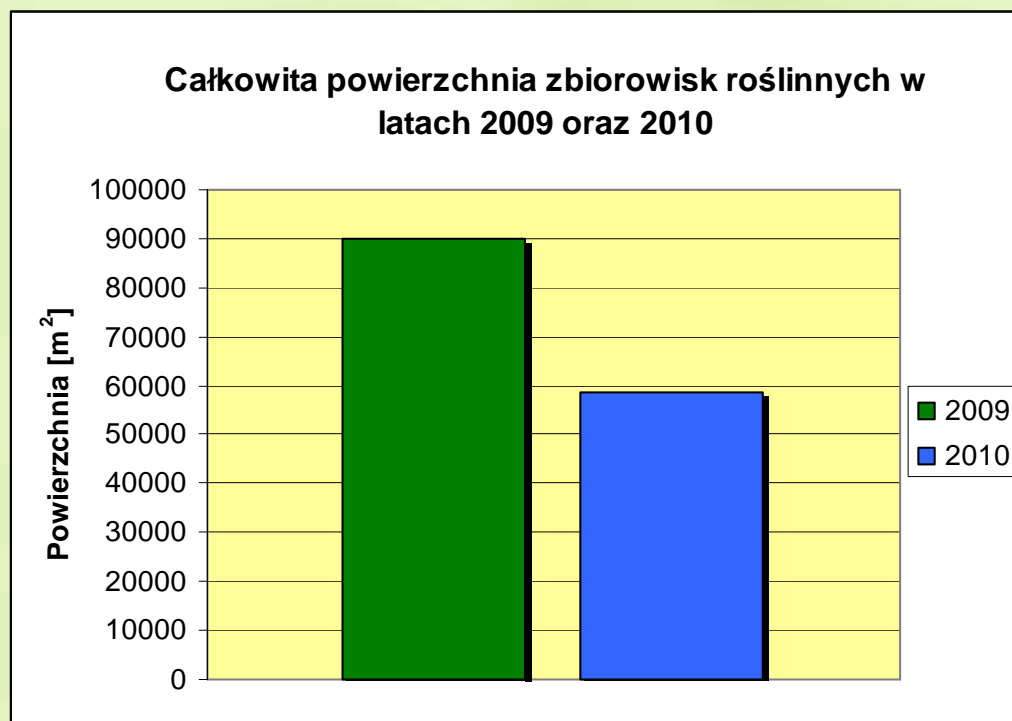
The comparison with 2009 year

- According to the latest research, the value of total macrophytes area was changed from **89925 m²** to **58725 m²**. This reduction was probably caused by unusually long winter, high water level and big nutrient load, which was observed in the spring.

2. The surface of emergent vegetation has been decreased but in other hand, we can observe new associations and increasing area of submerged vegetation.
