# The results of Lake Durowskie in Wągrowiec 2010

Joanna Rosińska  
Małgorzata Neumann  
Trang Huynh

# Water Quality in Lake Durowskie Wągrowiec Poland

2010

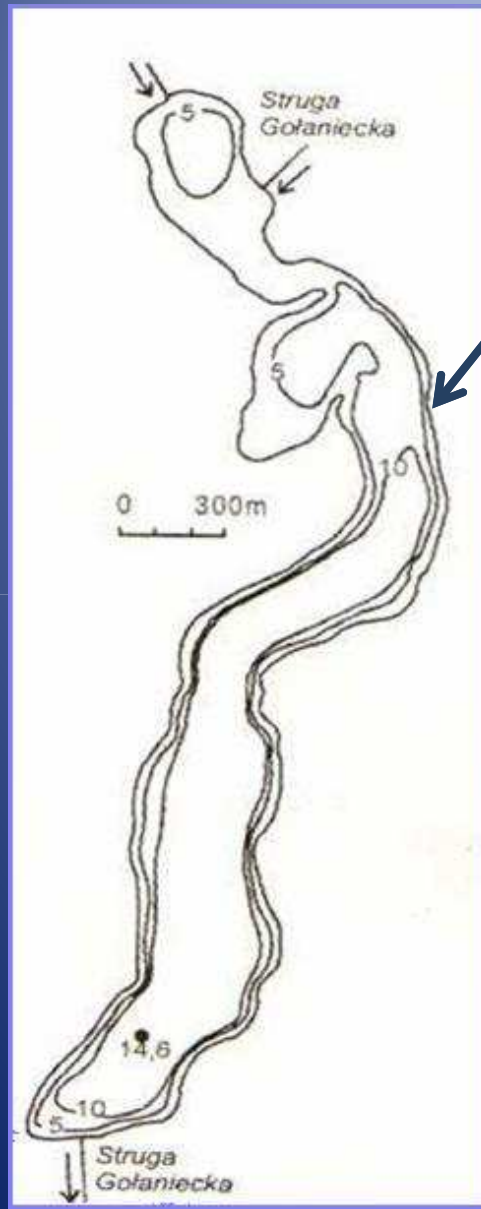
## 2. Study area

Surface	143.7 ha
Volume	11,322,900 m <sup>3</sup>
Max depth	14.6 m
Mean depth	7.9 m
Main tributary	Struga Gołaniecka
Surface of the whole catchment area	236.1 km <sup>2</sup>
Surface of the direct catchment area	1,581.3 ha
Share of agricultural area	58.26%
Share of forests	33.52%
Urban area	8.25%

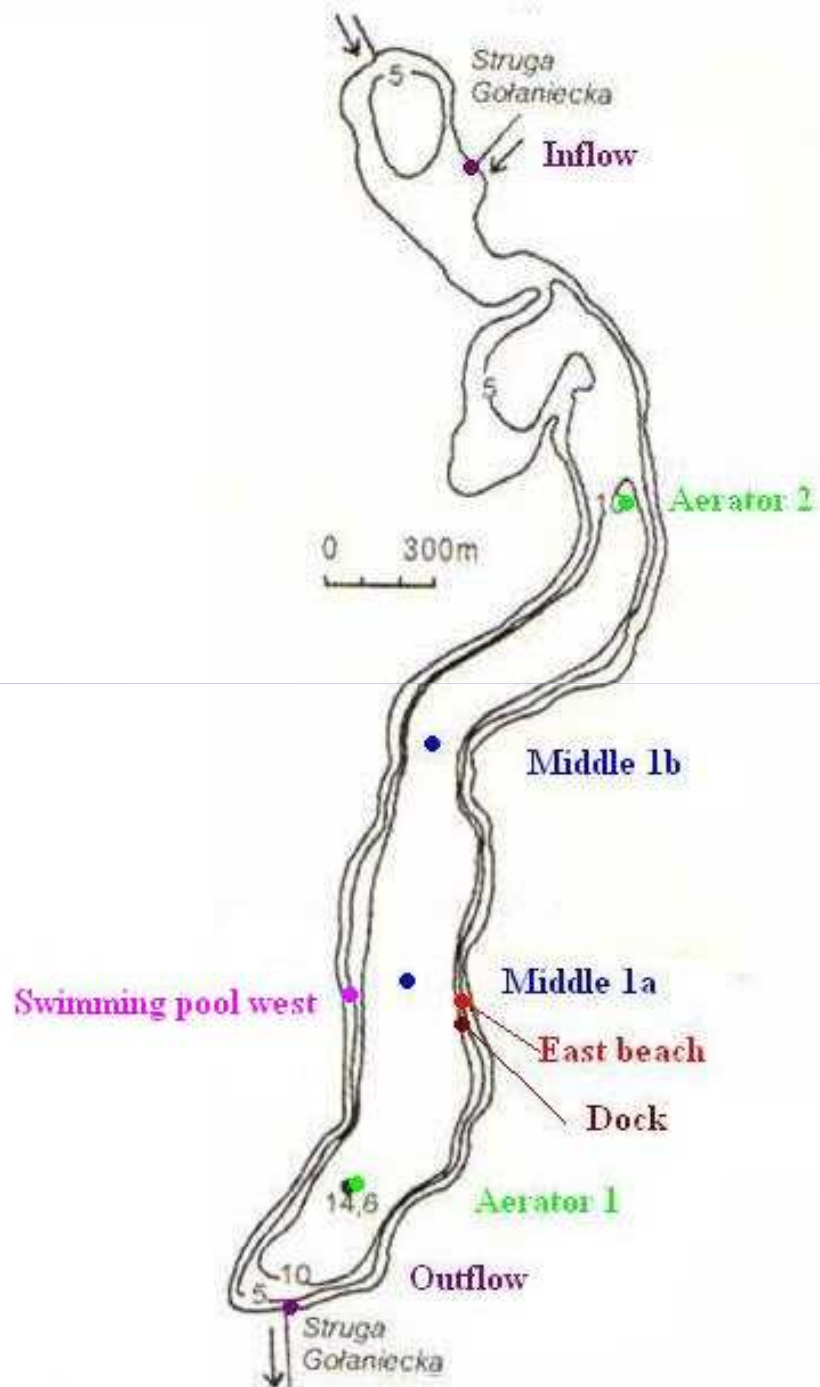
# 3. Sampling sites

Number	Sampling sites
1.	Aerator 1
2.	Aerator 2
3.	Middle 1a
4.	Middle 1b
5.	Swimming pool west
6.	East beach
7.	Dock near swimming pool
8.	Inflow
9.	Outflow

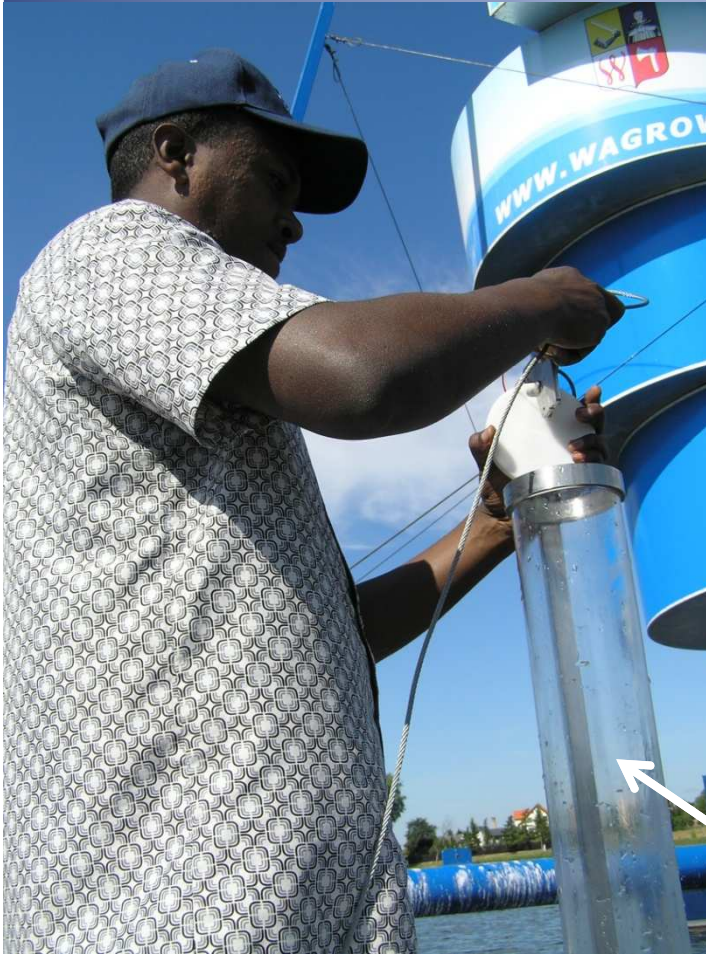
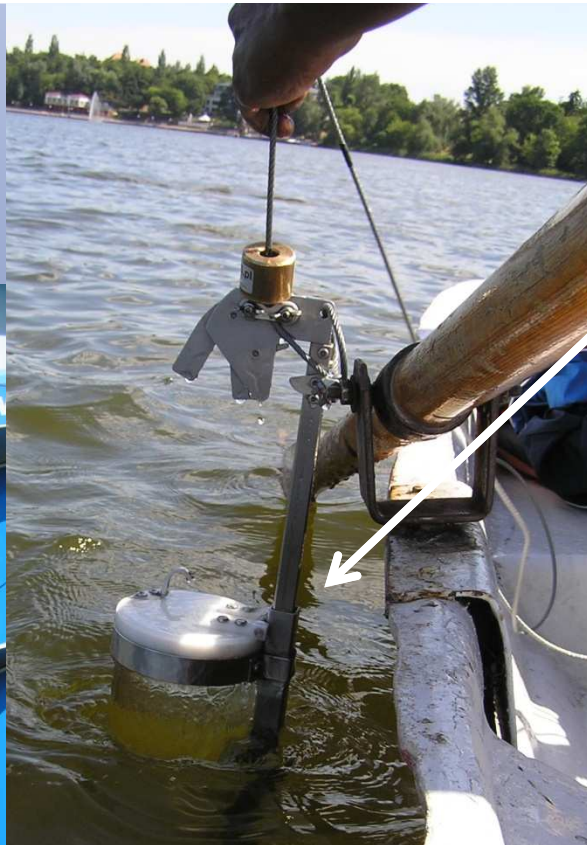
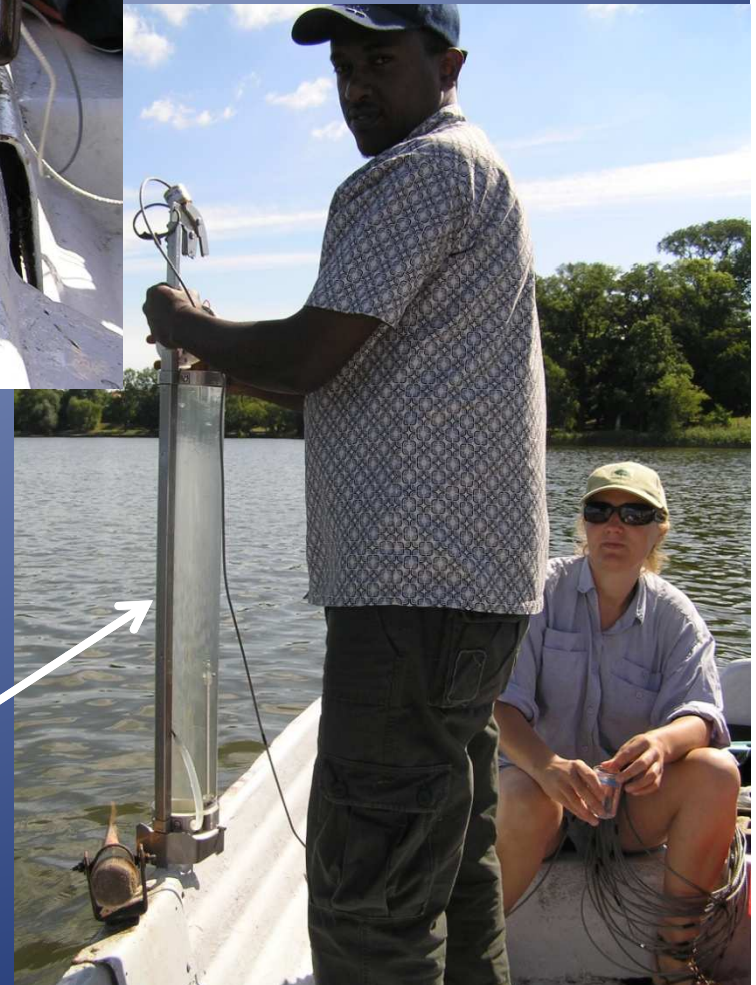
Bathometer  
used to taking  
samples of  
chlorophyll *a*

- Chlorophyll *a* – bathometer
- Water parameters – computer sonde of the YSI incorporated type (556 MPS)
  - Cycle of aerator – counting
- Secchi disc transparency – SD into water
  - Fishing sites and beaches - counting

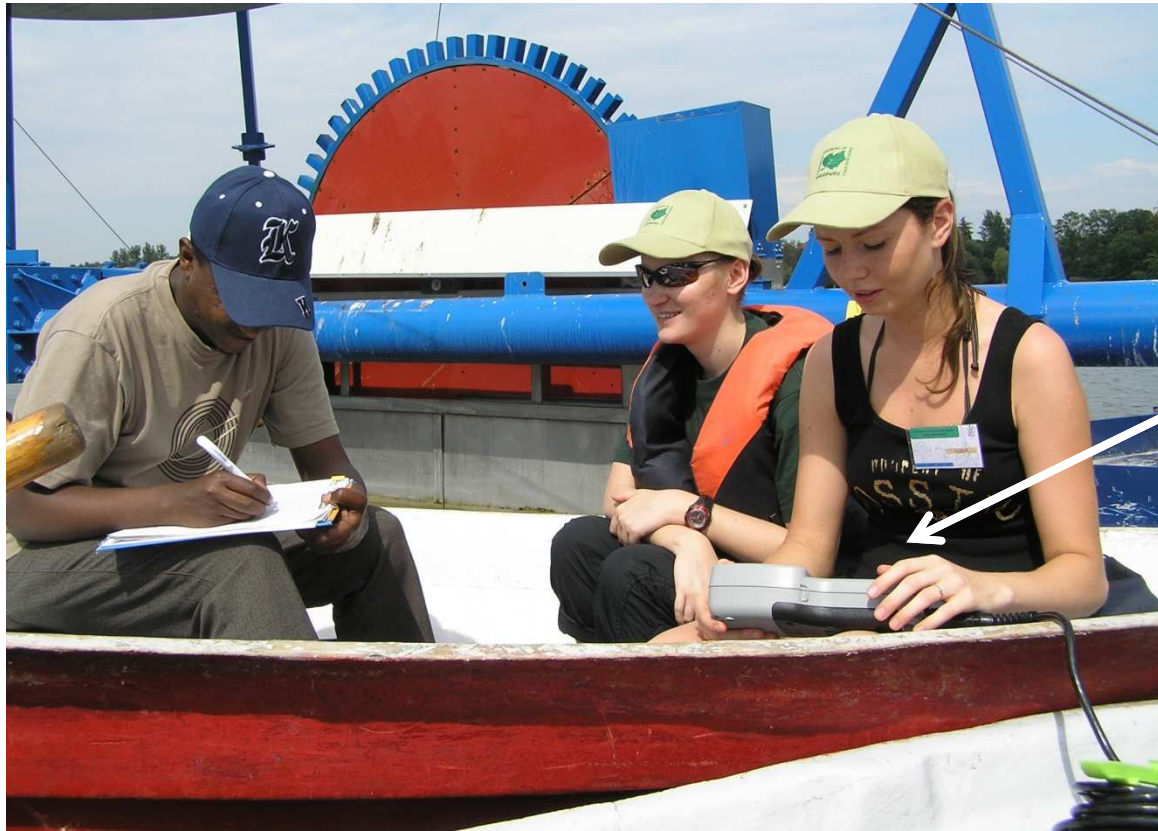
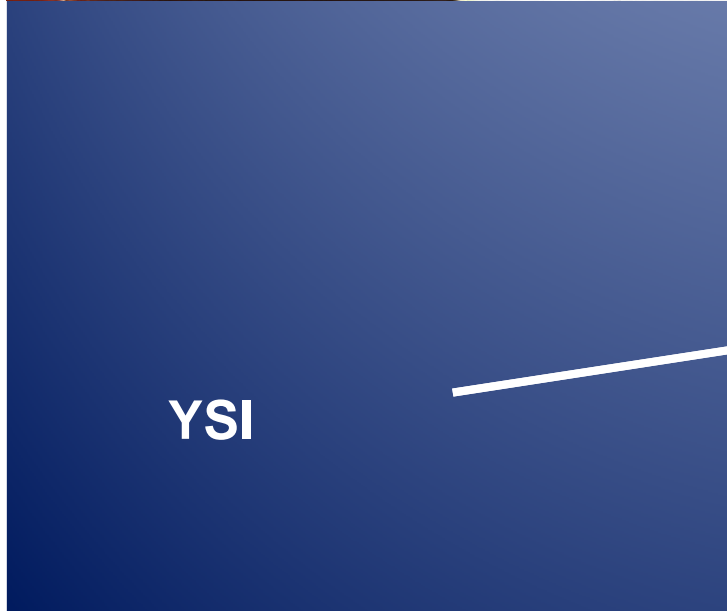
Computer  
sonde of the  
YSI  
incorporated  
type (556  
MPS)

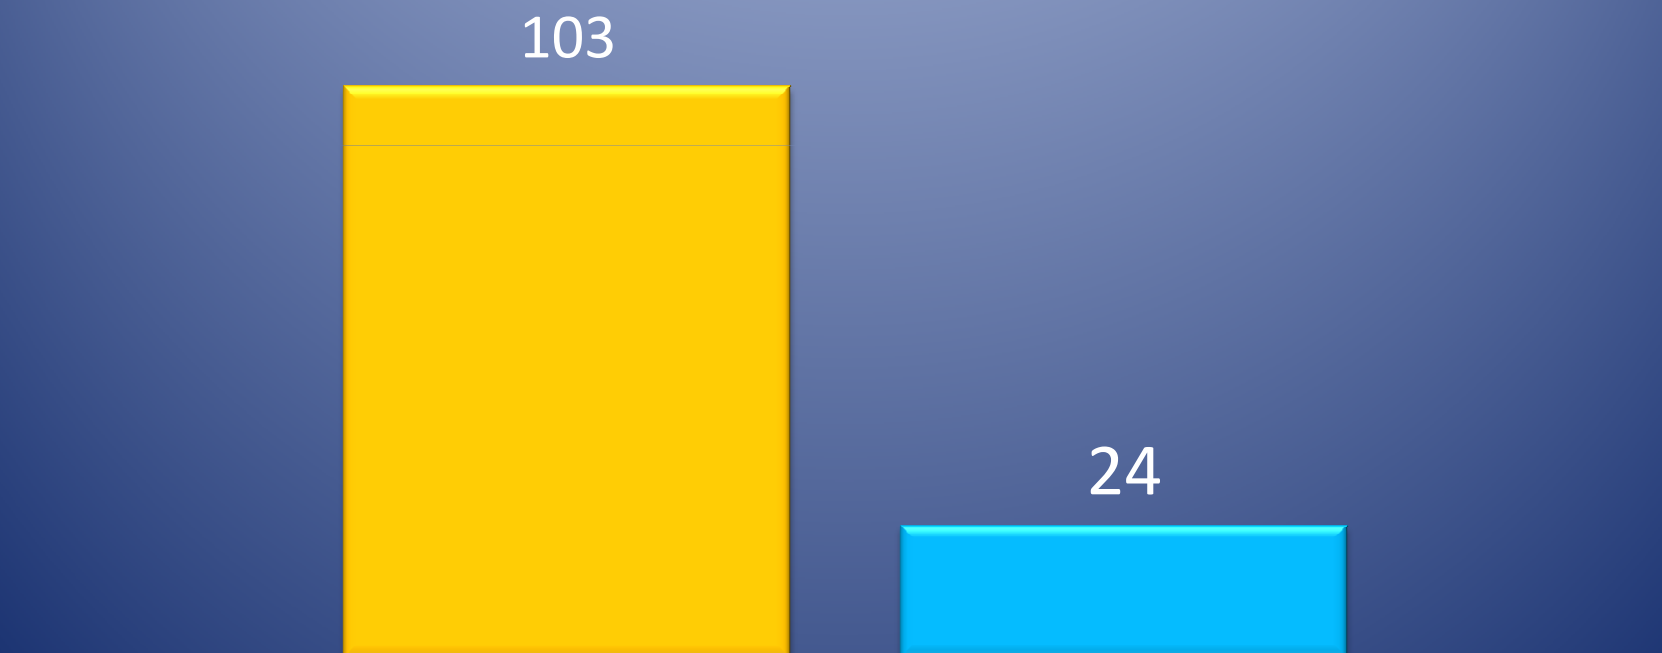
## Amount of fishing and swimming localities

■ Lake Durowskie Fishing sites    ■ Lake Durowskie Swimming sites

Z reguły 50 % aktywnych stanowisk wędkarskich !

- Reduce fishing places and beaches
- Improve quality of Gołaniecka Stream
- Support rotating aerator 2
- Reduce the surface inflow to the lake
- Create drainage ditch

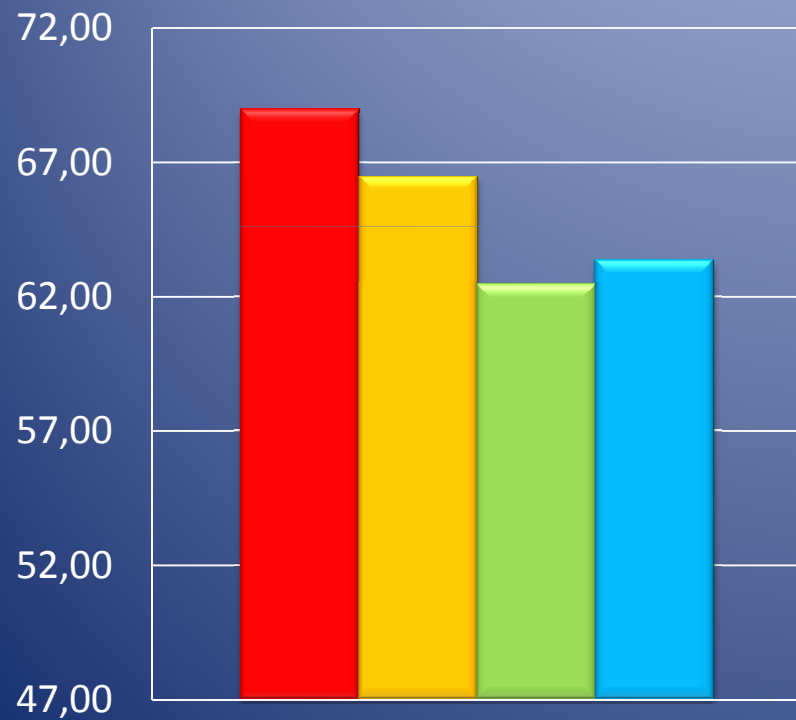
## TSI (Chl) in 2009

**EUTROPHIC STATE!!! (Carlson)**  
Eutrophy – 51- 85  
Mezo – Eutrophy 45 - 50

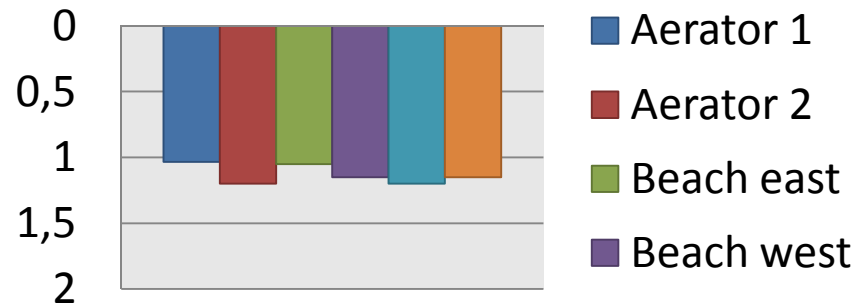
Visibility of Secchi disc  
(SD) (m) in 2009

Aerator 1	2009	2010
SD (m)	1,03	1,53

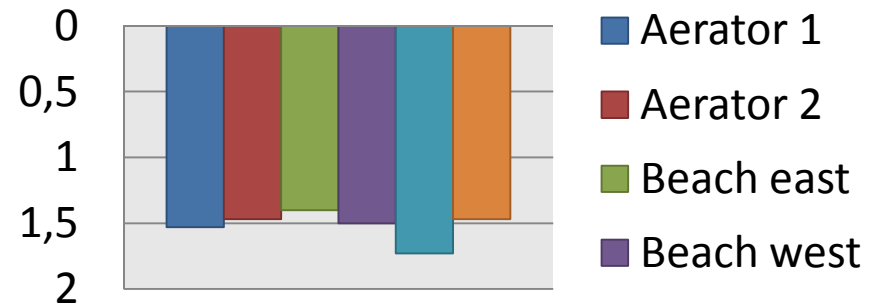
Visibility of Secchi disc  
(SD) (m) in 2010

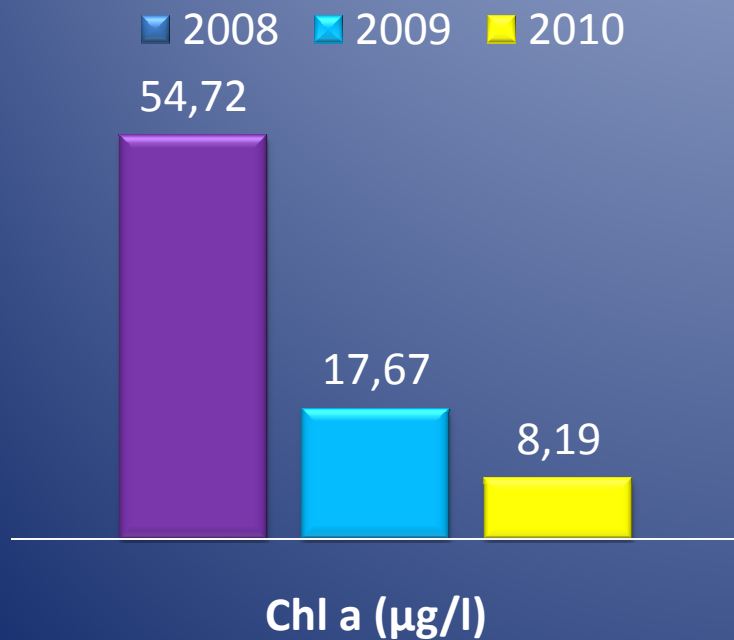
Compare average of chlorophyll *a* 2008-2010

Chl *a* (µg/L) 7.3—56 Eutrophic !!!(Carlson)

Chlorophyll a	2009	2010
Aerator 1	19,9	7,44
Aerator 2	15,44	8,93

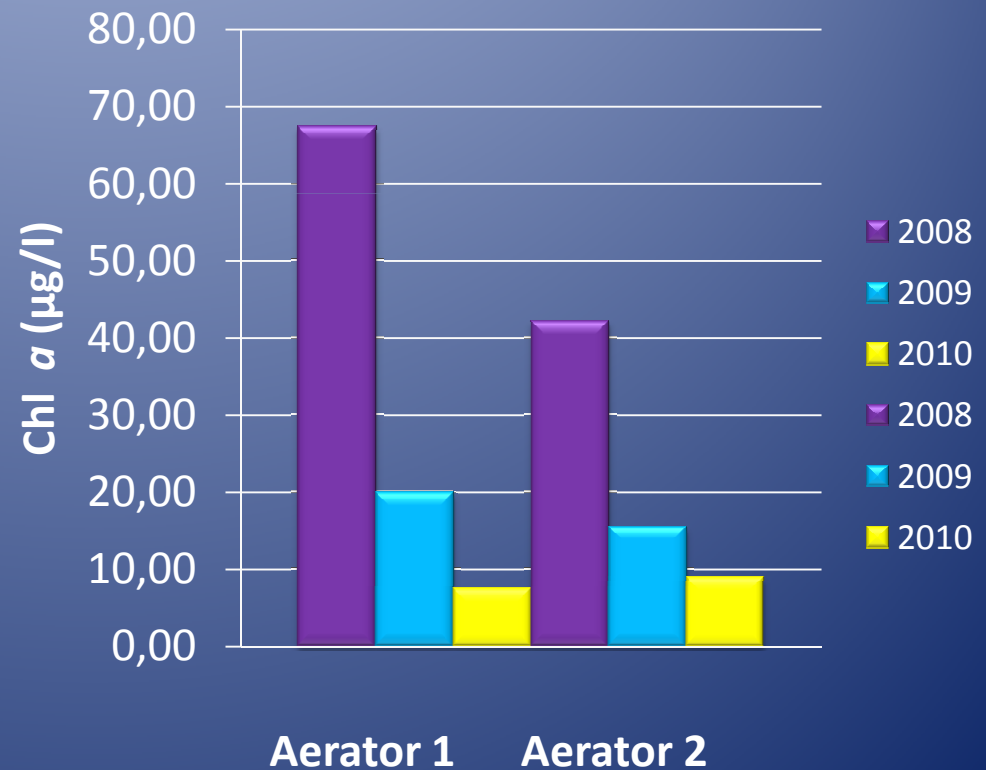
Compare work of Aerator 1 and Aerator 2 in 2008-2010

All index show that lakes is EUTROPHIC  
Aerators not working good in hypolimnion layer !

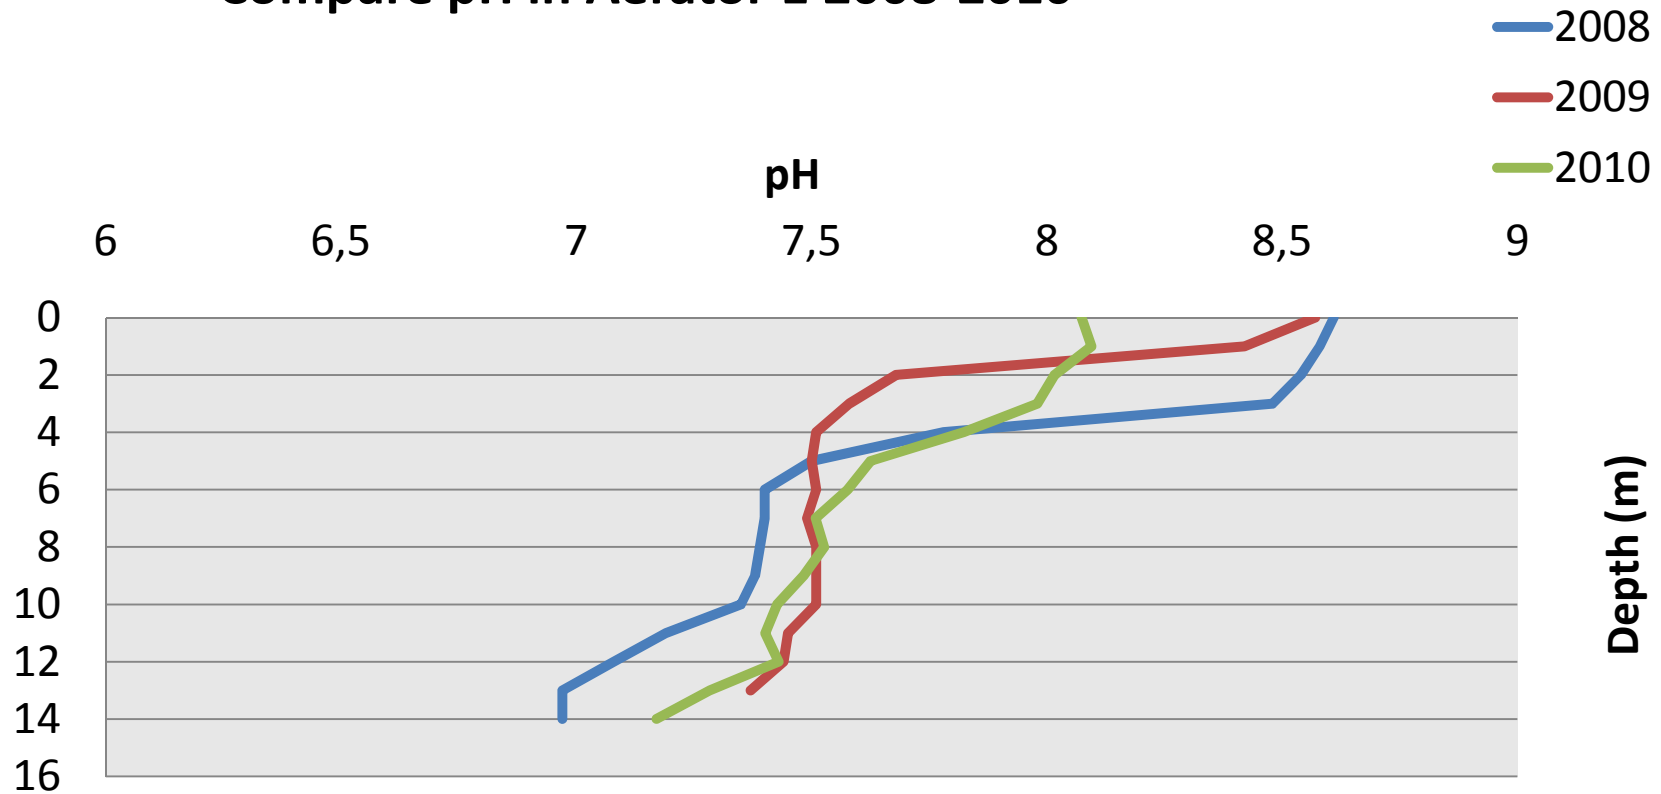
Compare pH in Aerator 1 2008-2010

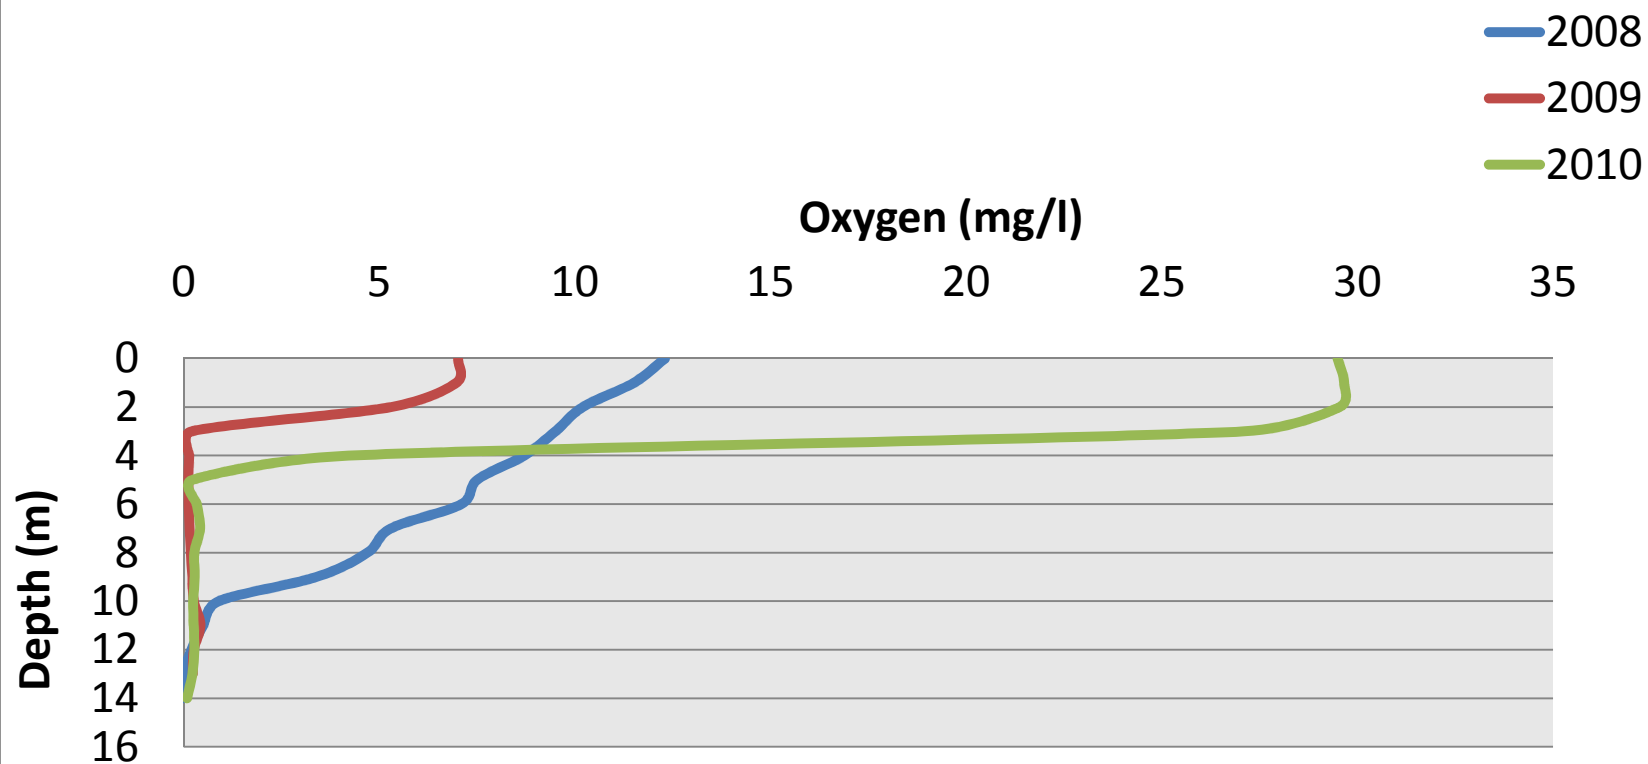
Compare oxygen (mg/l) in Aerator 1 2008-2010

Aerator 1	2006	2007	2008	2009	2010
Oxygen (mg/l)	7,1	7,3	12,3	7,0	29,5

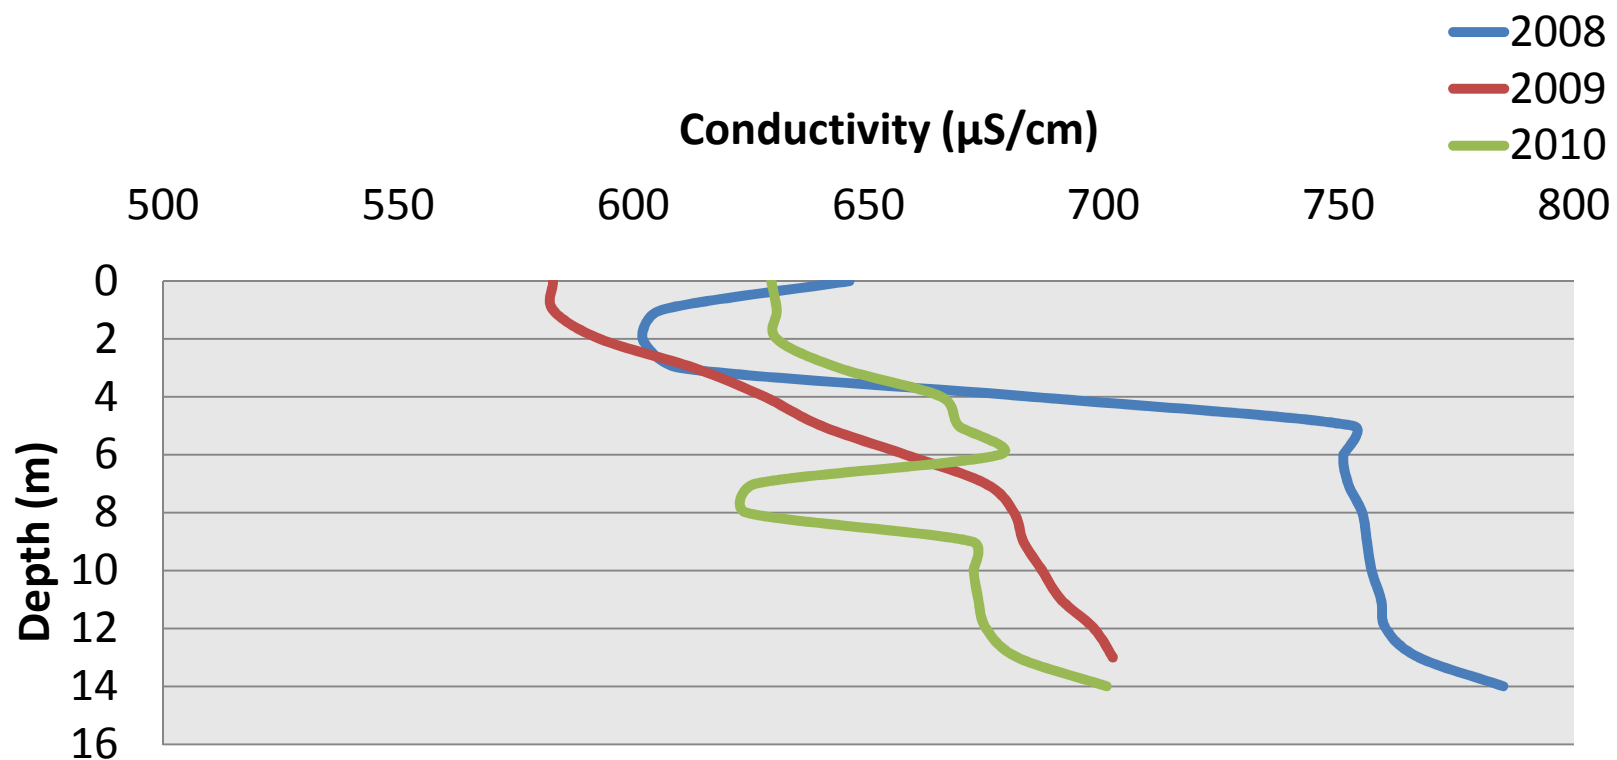
Compare conductivity ( $\mu\text{S}/\text{cm}$ ) in Aerator 1 2008-2010
