INTERNATIONAL SUMMER SCHOOL - DUROWSKIE LAKE

Wągrowiec & Poznan

(July 2014)

HYDROLOGY AND LAKE MANAGEMENT REPORT

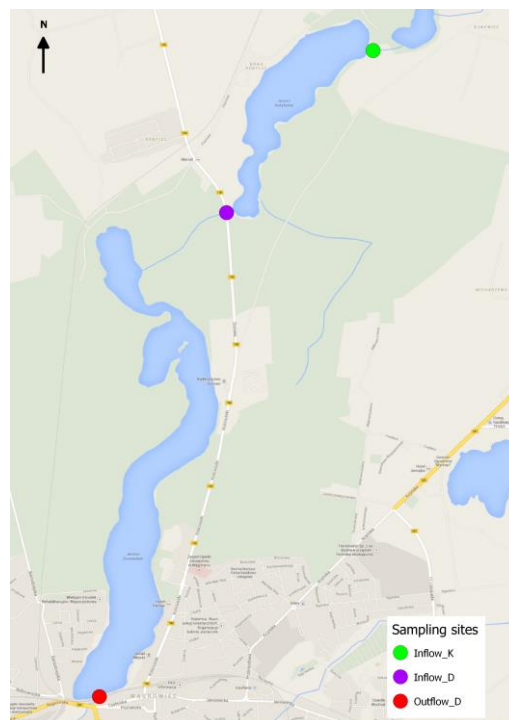
We collected the water samples and made discharge measurement from three different locations including inflow and outflow of Durowskie Lake and inflow of Lake Kobyleckie from 30th June till 5th July 2014. Inflow of Kobyleckie Lake (Inflow_K) is situated in the northern part of this lake with stones in the middle and muddy areas close to its shores. Inflow of Durowskie Lake (Inflow_D) is located towards northwards of this lake. We measured the discharge and collected water samples under the bridge situated at Road 190. This was the only place where could manage to go in the water to take samples and measure flow velocity. Outflow of Durowskie Lake (Outflow_D) is situated in the southern part of the lake. In addition to this some additional sampling and measurement of other water quality parameters was also made in the three upstream lakes including Lake Laskownickie, Lake Grylewskie, and Lake Bukowieckie were taken 5th July 2014.

Figure 1: Map showing the sampling locations for water quality assessment tests

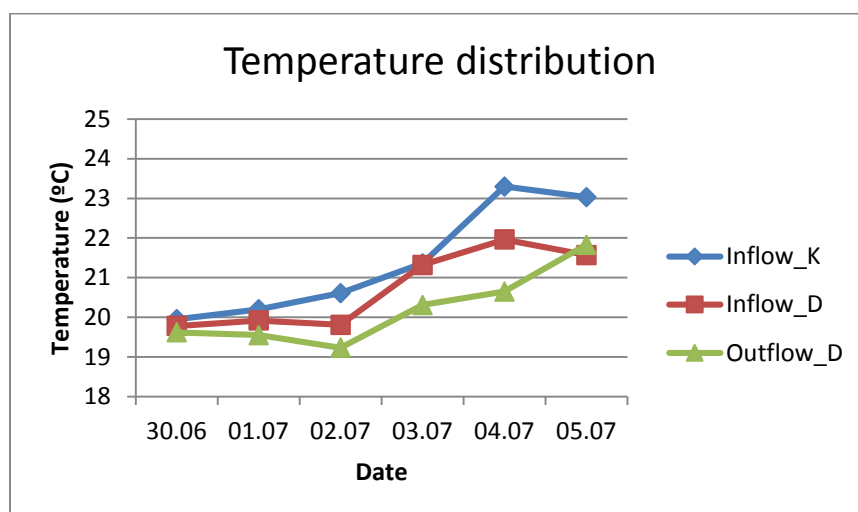
Temperature is an important parameter of water which has a major influence on the biological activity of aquatic organisms. It has also an impact on other physical and chemical parameters in this kind of environment. Since the graph shows an increasing tendency of temperature with every passing day which is due to summer season.

Figure 2: Measurement of temperature from the three sampling locations

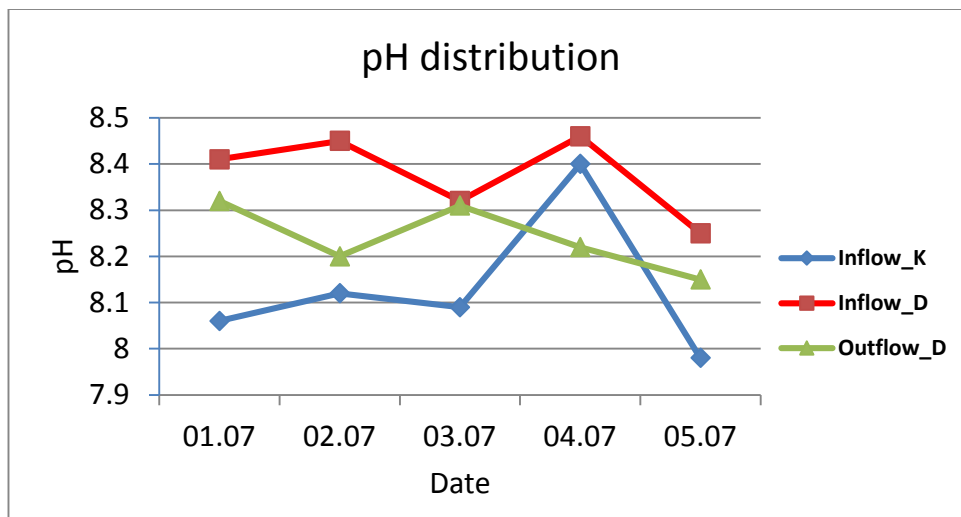
The overall pH value was fluctuating during different days of sampling. The lower pH level was noticed for Inflow_K and the highest for Inflow_D. This could also be an indication that in Kobyleckie Lake primary production is high and has a negative impact on Durowskie Lake.

Figure 3: pH range from the three sampling locations

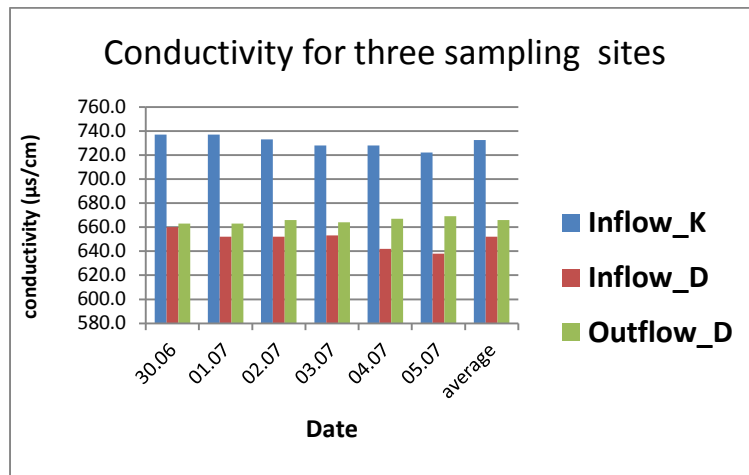
Conductivity indirectly measures presence of inorganic solid including Phosphate and nitrates. The higher the amount of such solids in the water the higher would be the conductivity. The results have shown the samples taken inflow of the Lake Kobyleckie during all six days have the highest conductivity. This higher level of conductivity indicate presence of higher loads of Phosphorus into this part. Whereas the conductivity of the sample collected from Inflow and outflow of Lake Durowskie were almost similar and had much more lower conductivity than the Inflow of Kobyleckie

Figure 4: Measurement of conductivity at the three sampling sites

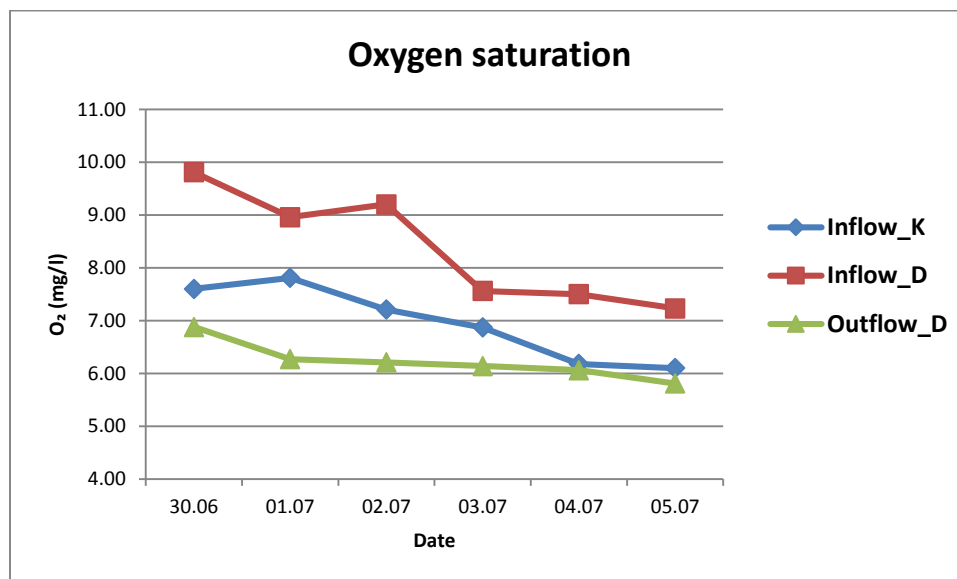
The outflow of Lake Durowskie in average has the lowest oxygen saturation which is probably due to the highest rate of decomposition. The inflow of Lake Durowskie interestingly showed highest amount of oxygen saturation during the first two days and the later days it was recorded between 7 and 8. The higher level of oxygen saturation during the first two days of sampling in our opinion were attributed to the heavy rains during the sampling.

Figure 5: Oxygen saturation in three lakes

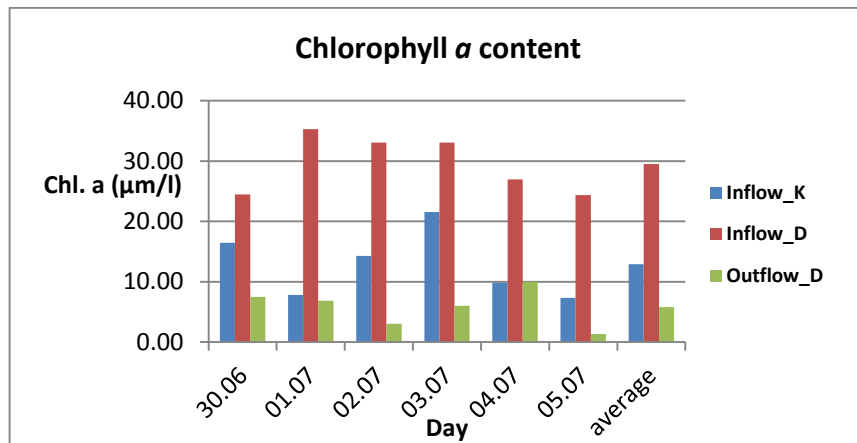
The results of Chlorophyll *a* and TP contents were also not very different from the earlier, inflow Durowskie was the one carrying the highest amount of Chlorophyll *a* and TP contents for all six days of sampling. The inflow of Lake Kobyleckie was carrying the second highest amount of the Chlorophyll *a* contents. This can be an indication of high amount of algal biomass production due to excessive loads of nutrients.

Figure 6: comparison of Chlorophyll *a* content with previous years

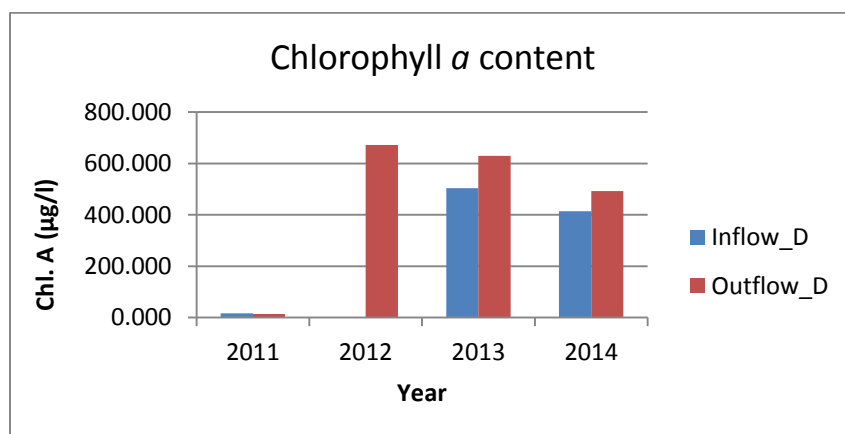
Furthermore we also compared the results with the past years to see if the amount of Chlorophyll *a* and TP contents have been changed within this duration at the inflow and outflow of Lake Durowskie. It was noticed that the amount of Chlorophyll *a* have been decreased in comparison to year 2013 in case of outflow of the lake. Whereas in comparison to 2012 the Chlorophyll *a* for both inflow and outflow has been decreased.

Figure 8: comparison of Chlorophyll *a* with previous years

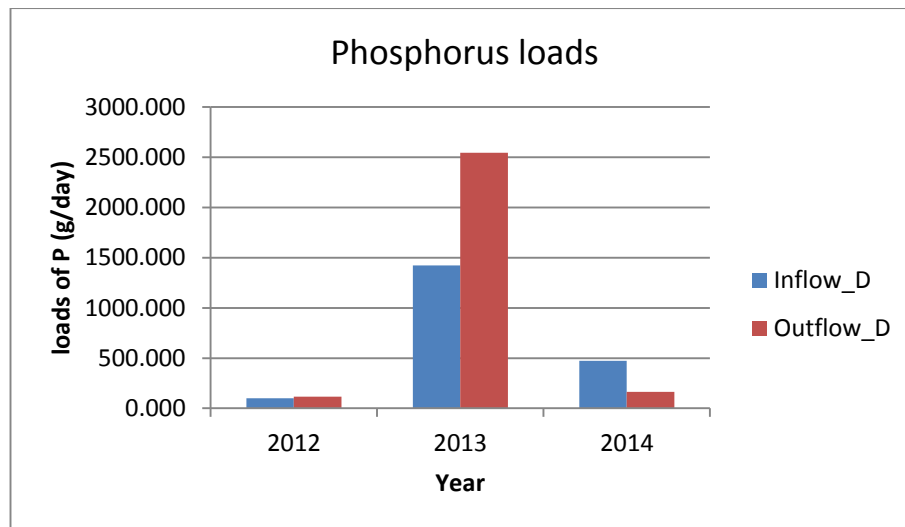
Whereas the TP have almost at the same level as in 2012. These results however are not comparable with the 2013 as the heavy rains last year caused heavy loads of erosion into the lake and hence the elevated the amount of Phosphorus beyond the expected levels.

Figure 9: comparison of Chlorophyll *a* with previous years

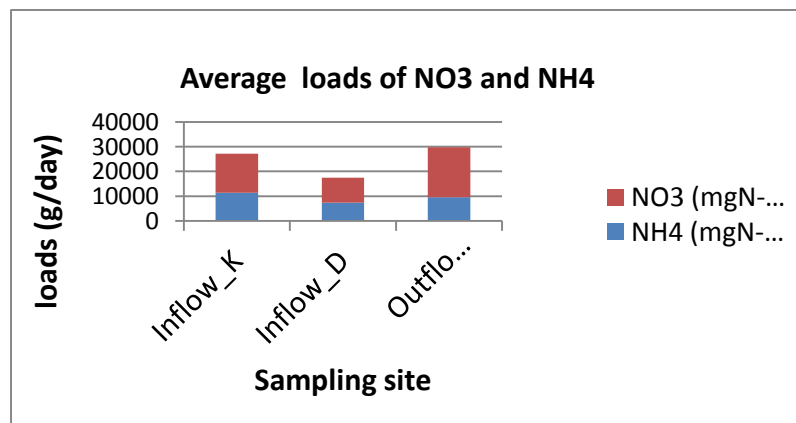
The loads of NH_4 were higher in both outflow of Durowskie and at the inflow of Kobyleckie. This was a little deviated from the previous result where the outflow of Lake Durowskie was showing less percentage of different measured parameters.

Figure 10: Average load of NO_3 and NH_4 in three sites

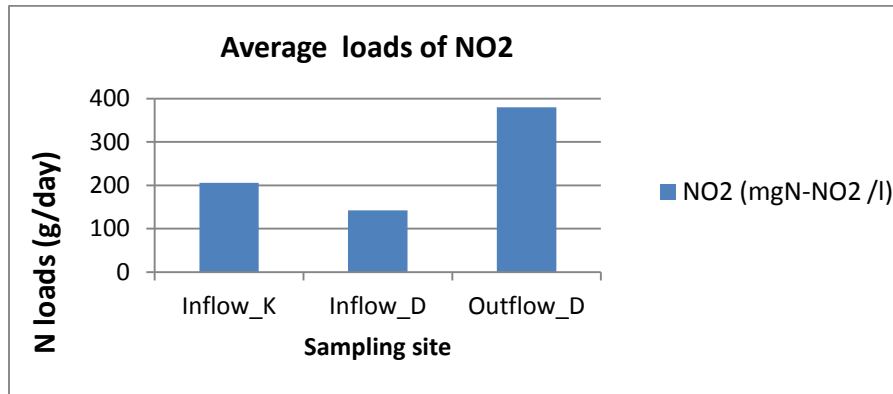
Figure 11: Average load of NO₂ in three sites

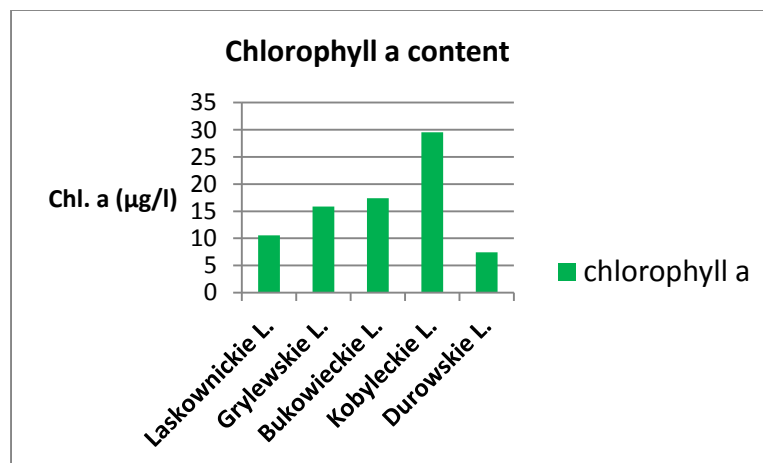
The analysis of chlorophyll *a* content helped us to provide the sufficient prove to support our idea that the upper lakes are also contaminated. The figure below highlights that chlorophyll *a* content are increasing from upstream towards downstream lakes starting from Laskownickie and ends at Lake Kobyleckie. Since Lake Durowskie is an outflow of Lake Kobyleckie hence all the contaminants from these sources are ended-up accumulating in the Lake Durowskie.

Figure 12: estimation of Chlorophyll *a* contents from the Upper lakes

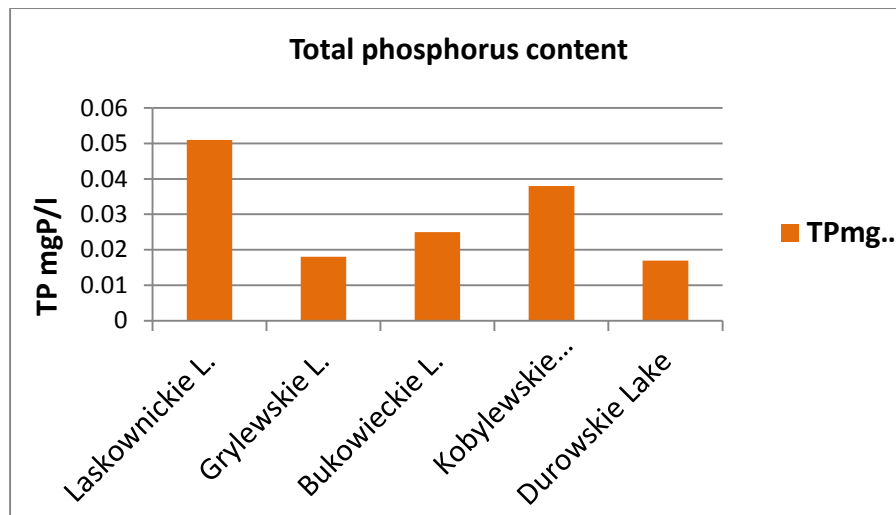
The same trend in terms of Total Phosphorus (TP) contents was observed in the upstream lake i.e TP was increasing from upstream to downstream with one exception of Lake Laskownickie. The elevated level of TP in this lake is due to extensive agricultural activities in the catchment areas of which are contributing higher loads of the phosphorus into the lake. This lake can be one of the areas where the extraction of water from hypolimnion can be a possible solution to improve the water quality.

Figure 13: estimation of Total Phosphorus contents from the Upper lakes

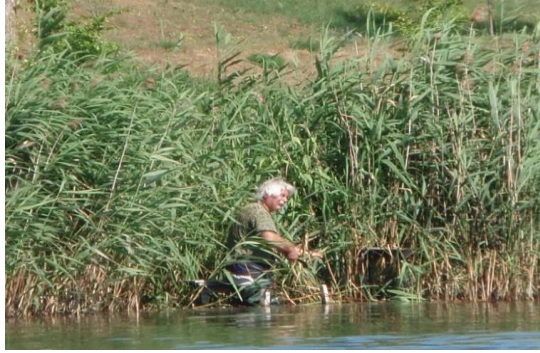
Fishing activities led towards the shoreline erosion and also affecting the littoral vegetation. The construction of fishing docks implies the cutting of shoreline macrophytes and in general their structure do not allow emergent vegetation to grow underneath. In some cases macrophytes are even impeded from growing in the areas next to docks, as swimmers also use such openings. Furthermore, many fishermen destroys the shoreline during the construction of fishing platforms and fishing spots which are more common in the southernmost part of the lake. This creates many littoral vegetation gaps that, according to calculations done by the previous summer school students which makes upto 1 km in total length and 920 m² in total surface area in the past years.

Figure 14: a fishermen harvesting macrophytes along the shoreline

The contribution of the fishing platform in the shoreline erosion is also significant as fishermen clear macrophytes for building these platform. There are several ways through which the erosion associated to these fishing docks can be minimized without disturbing the privilege for the people to enjoying fishing in lake Durowskie. We during the field visit around the lake observed a number of abandoned fishing platforms which are no more use by anyone. One suggestion to the authority which issue licenses to the people for building fishing docks would be that rather than allotting new undisturbed areas for fishing platform building they should try to repair the abandoned ones. Reuse of these platforms would reduce number of new platform and hence would help control macrophytes harvesting.

Change the designing of the fishing platform could also be an effective strategy to control the clearing of macrophytes from the shore. We noticed that the use of such fishing platform is already in practice. The relevant authority can specify the designs of the fishing platform which should be built. Trainings for the fishermen regarding building and maintenance of such preferred platforms can be organized in order to make people enable to build them by themselves and also to make it cost effective.

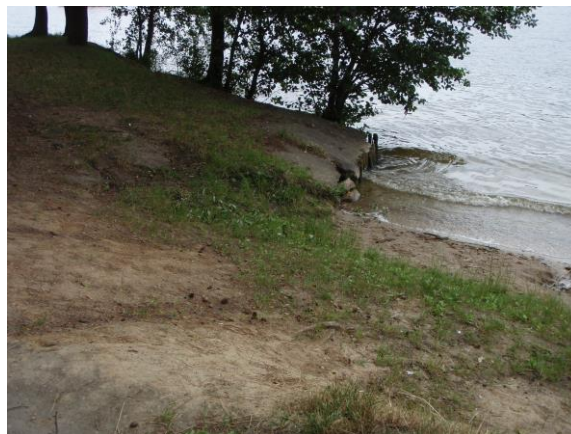
In our observations an increased runoff was attributed to the un-planned infrastructure of access ways to the Lake. We saw several stairs sections and boat access ways that lead directly to Lake Front without any sediment retention walls or structures that could slow down the rain water flow. Consequently, these accesses ways strongly channel rain waters to a single point, multiplying their velocity and erosion capacity, especially during summer storms, which destroys the littoral vegetation and potential the wave erosion on the beach. We observed that people have also put some retention structures such as plastics and wood in front of access ways to control shore-line erosion.

Figure 15: shoreline erosion around along the shoreline

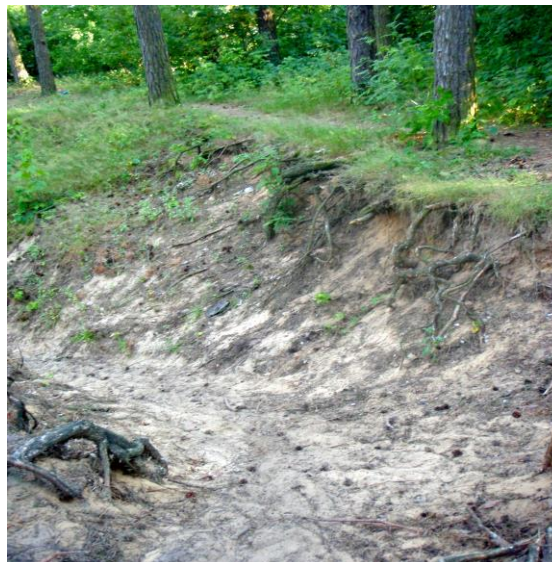
We observed around 20 new path ways made by locals and visitors that, intensified by the steep morphology of the lake basin, have slowly created big cuts without any vegetation coverage and huge erosion potential. According to our measurements we estimate that one such cut means a loss of 30 m^3 of soil, summing-up 640 m^3 in total, which equals to the carrying capacity of 36 Lorries. Considering the input levels of P into the lake through the water inflow, and

Furthermore, we could spot a number of sport and recreational activities with great erosive effects. Motorboats, apart from its annoying acoustic disturbance, they also produce evident wave erosion on the shore. Besides, mountain bikers have totally transformed some places in the forest by excavating the ground for soil and building big hills suitable for their leisure sport, making huge paths for further erosion and sand run-off that finally reaches the water, which is situated only few metres ahead. And in last place, in some cases hiking and biking trails have fomented extensive erosion to surrounding areas. Such is the case of a beach situated in the southern-west shore of the lake, on the right of the main hotel of that lake's side. This open littoral gap suffers from wave erosion from the inside of the lake and also from run-off along the steep introduced-conifer forest (conifer forest soils have a poorer ground vegetation that enhances erosion process in steep slopes). Through that beach pass a hiking-biking signalled route. This incites people to make a stop right there to rest and bath, what supposes further pressure in the site. We had a look of this place from the upper side too, to have a full idea of the dynamics of its degradation. Surprisingly, we found that the erosion was much greater of what we expected from the shoreline view. Not only runoff of surface ground is occurring but the whole soil structure is collapsing downhill, creating a big canyon of significant size. We esteemed its soil loss in 360 m³, which is comparative the carrying capacity of 20 Lorries.

Figure 16: Eroded channel resembles to Grand Canyon

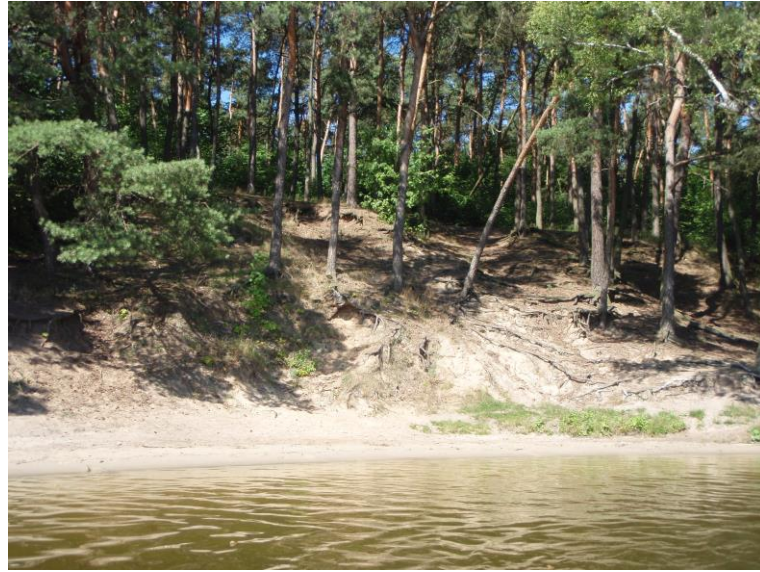
Figure 17: one of the highly eroded beaches close to the hotels at Lake Durowskie

Sealing/closing the areas for public access around the lake where the human disturbance led to the erosion upto the hazardous level would be an important step towards the restoration of such areas. The management can declare such areas as protected for a certain period of time and after restoration they can be open for the public access through the specified trails or pathways. Plantation on such highly eroded can be a possible solution to stabilize the eroded areas

especially along the hiking trails. Additionally this plantation can also act as a fence to manage the hiking trail and make sure that people use the specified trail to access the lake.

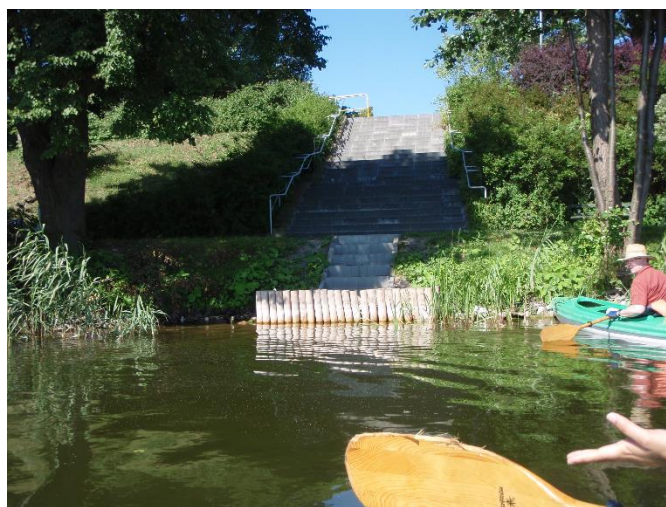
Use of structure such as sedimentation retention walls can be a solution to control flow of sediments into the lake. We observed the usage of such structures at the end of each trail.

Figure 18: Access point of the lake where sedimentation retention wall has been built

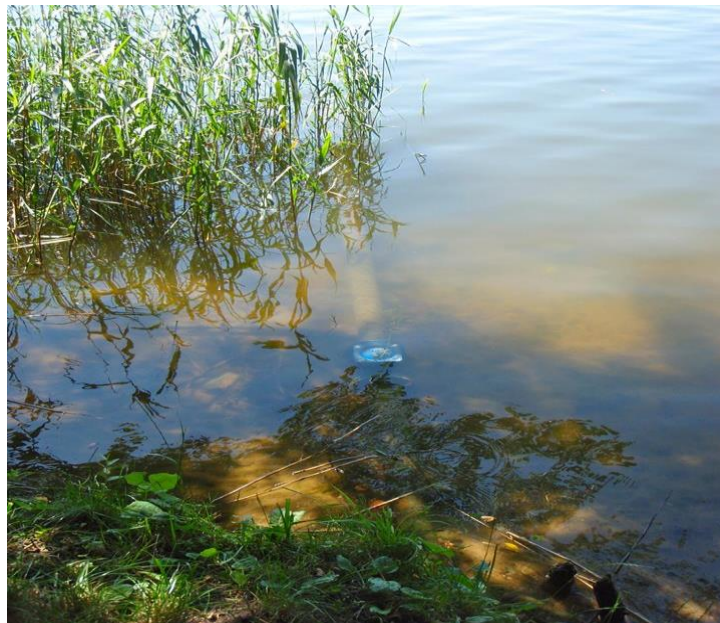
One strategy of deal with these elevated level of contaminants is the removal of water from the hypolimnion from Lake Kobyleckie. The method Water withdrawal from the hypolimnion is extraction of nutrient rich and oxygen deficient water from the bottom of the lakes through pumping. This is considered a low cost process and has been applied successfully in the past to restoration of eutrophicated lakes such as Lake Varese in Italy. (Zaccara 2007). Furthermore, this would not be a new initiative in this area as in the Lake Durowskie, the sports centre is already withdrawing water through pumping from the epilimnion.

Figure 19: Water withdrawal from the epilimnion in Lake Durowskie

This would also bring twofold benefits one in the form of improved quality of the water in the lake and the other one this nutrient rich water would act as natural fertilizer for the crops which would save substantial amount of money.
