HYDROLOGY & MANAGEMENT OF DUROWSKIE LAKE

INTERNATIONAL SUMMER SCHOOL
(Wągrowiec & Poznan – July 2014)

Aims of the study

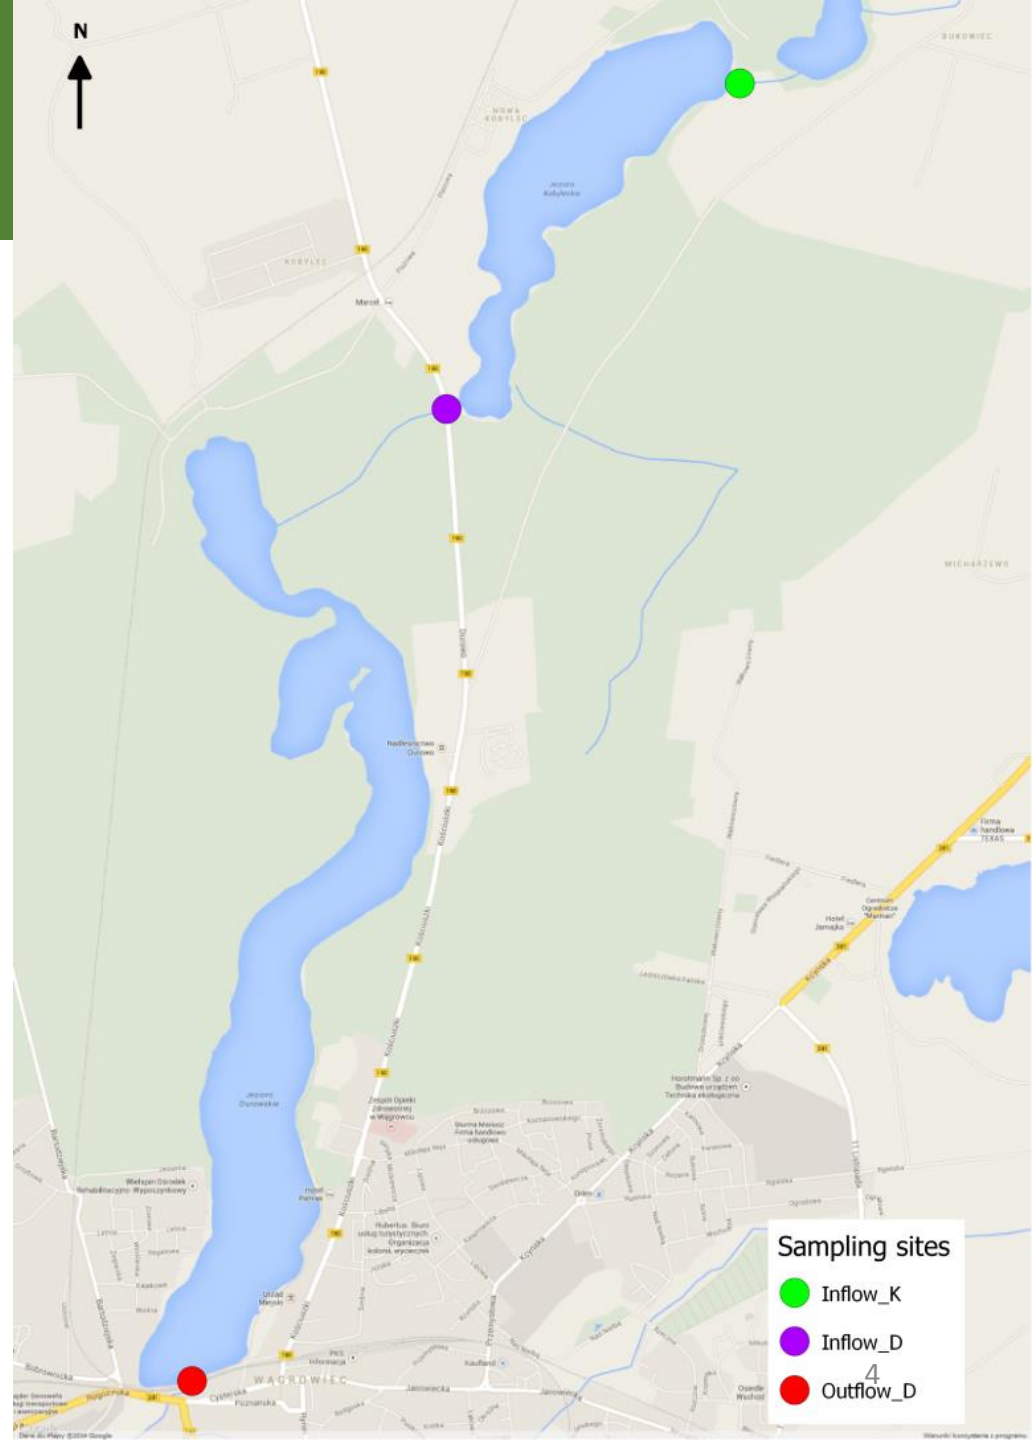
Sampling locations

- Inflow of Kobyleckie Lake
- Inflow of Durowskie Lake
- Outflow of Durowskie Lake

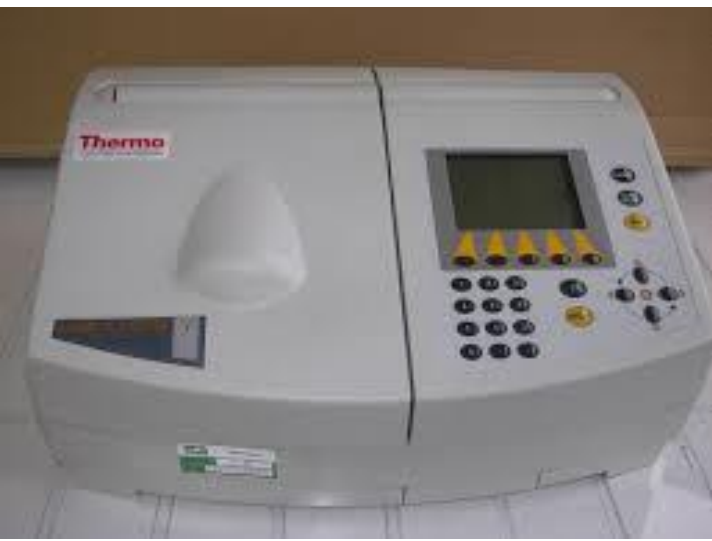
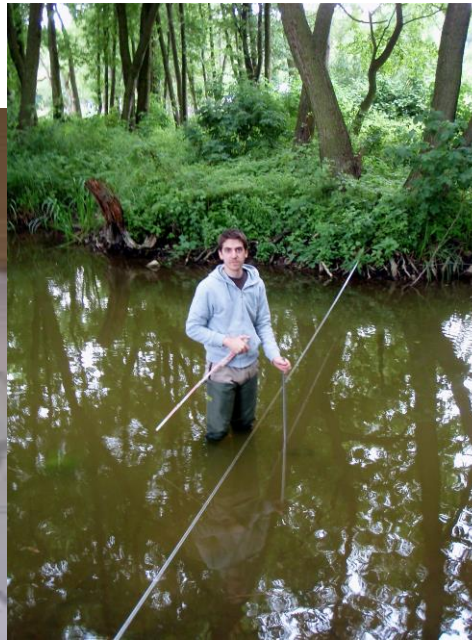
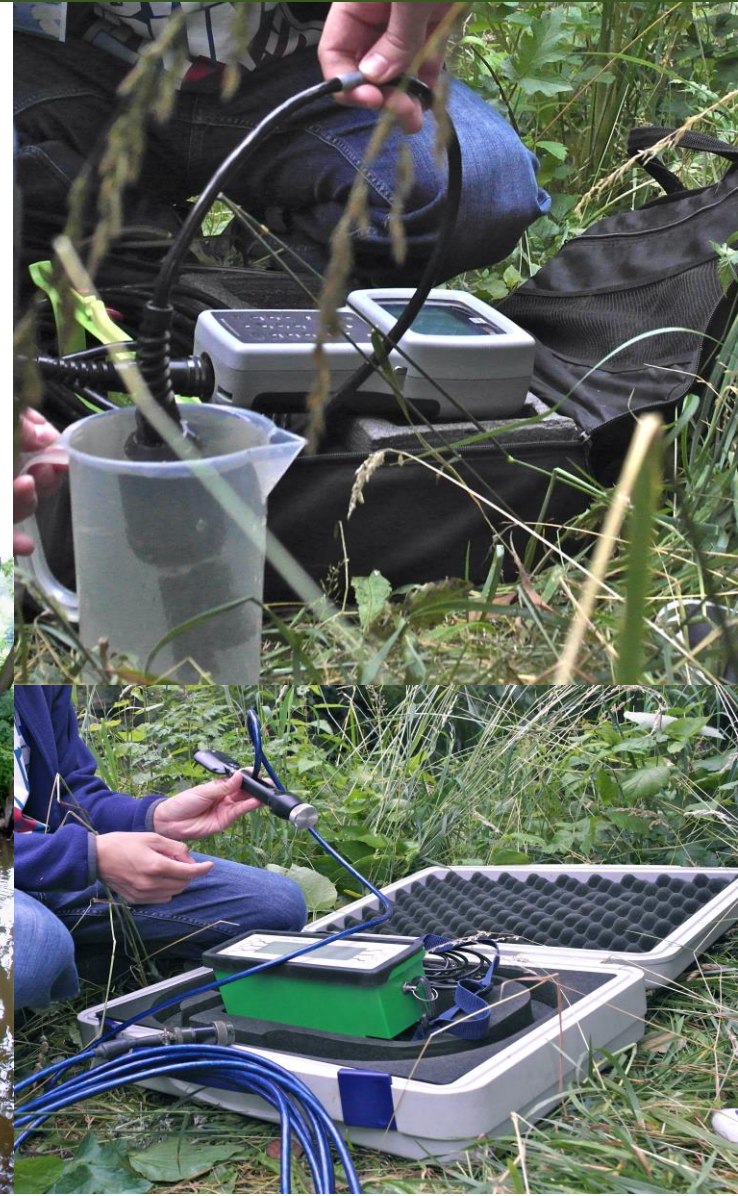
Methods: water quality assessment

- Handheld multiparameter meter
- Pocket pH meter
- Electromagnetic velocity meter
- Spectrophotometer

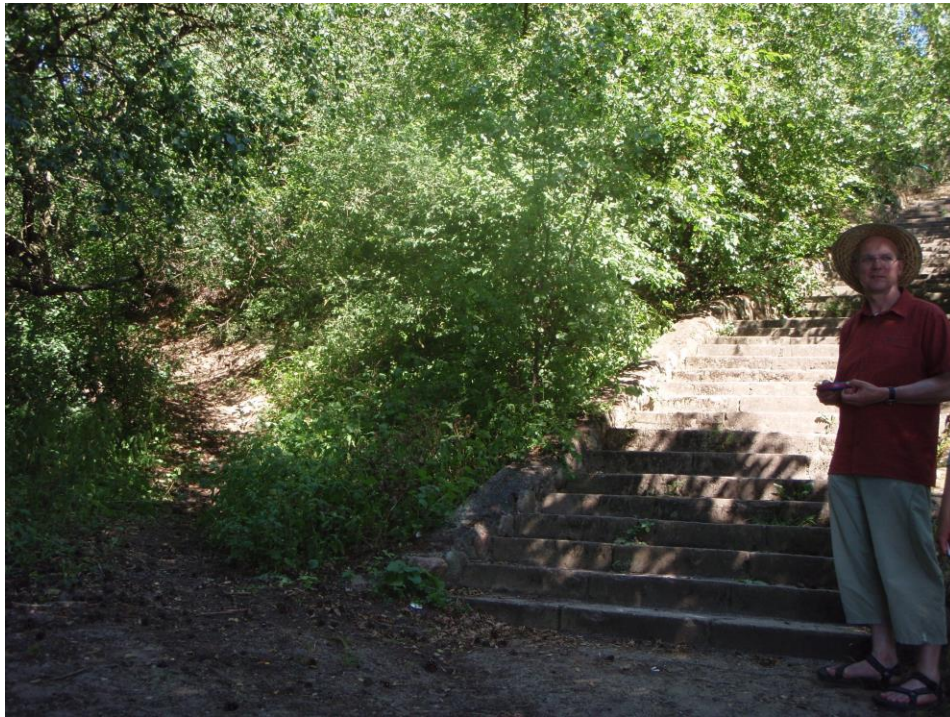
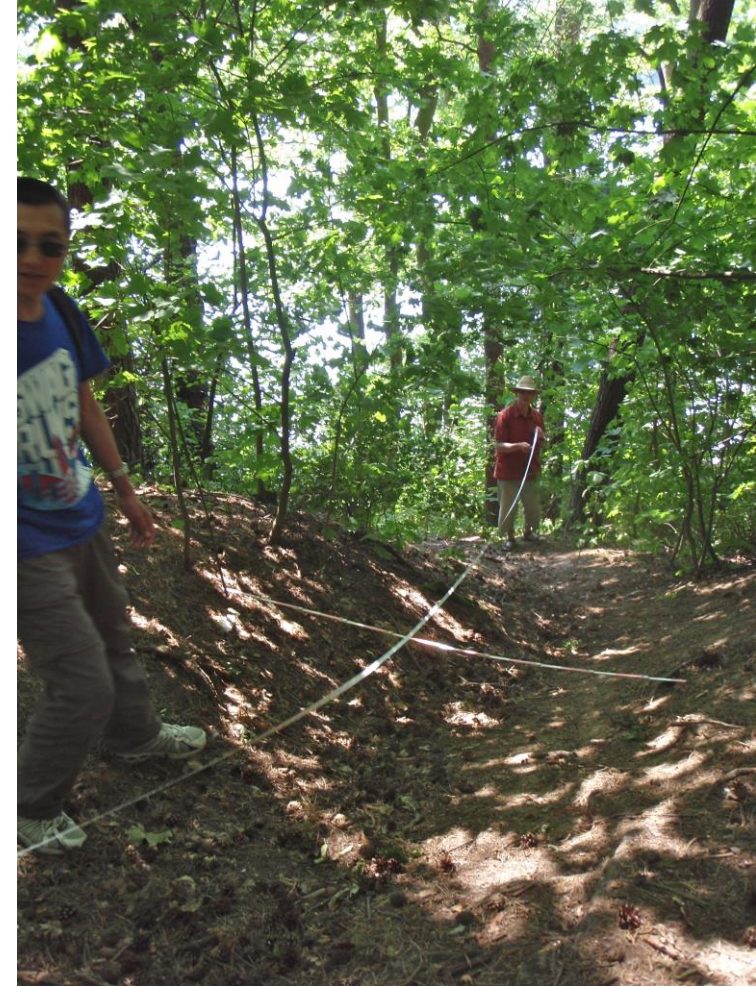
Shortcuts created by people

≈ 20 channels of 30 m^3 each
Total = $640 \text{ m}^3 = 36$ lorries

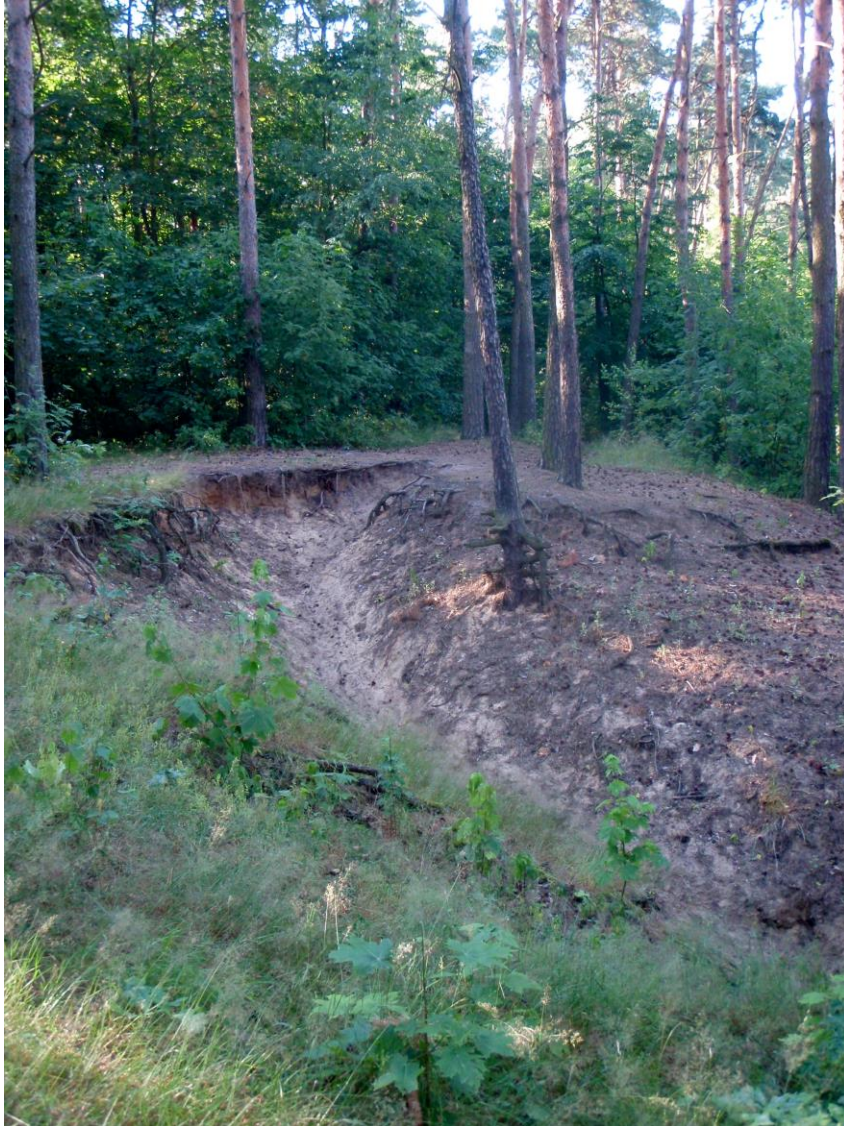
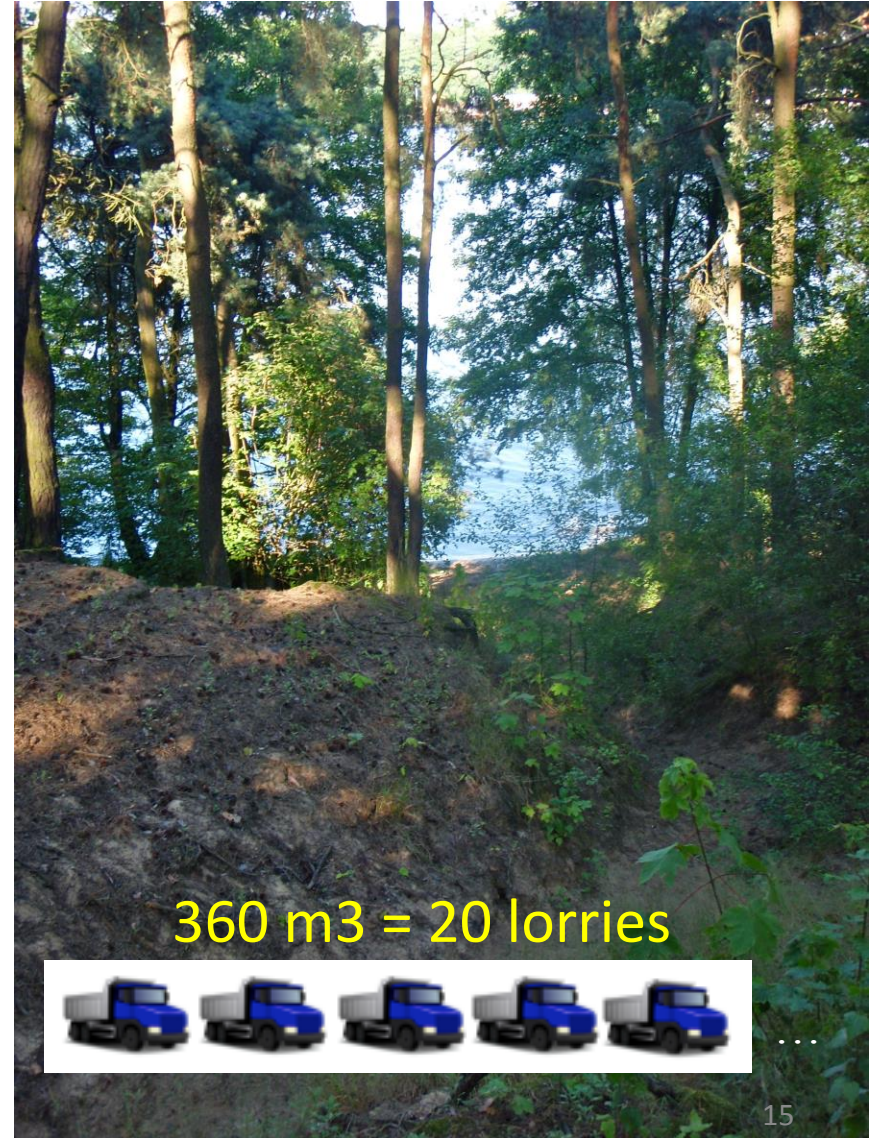
THE GREAT COLORADO CANYON OF WAGROWIEC !!!

360 m³ = 20 lorries

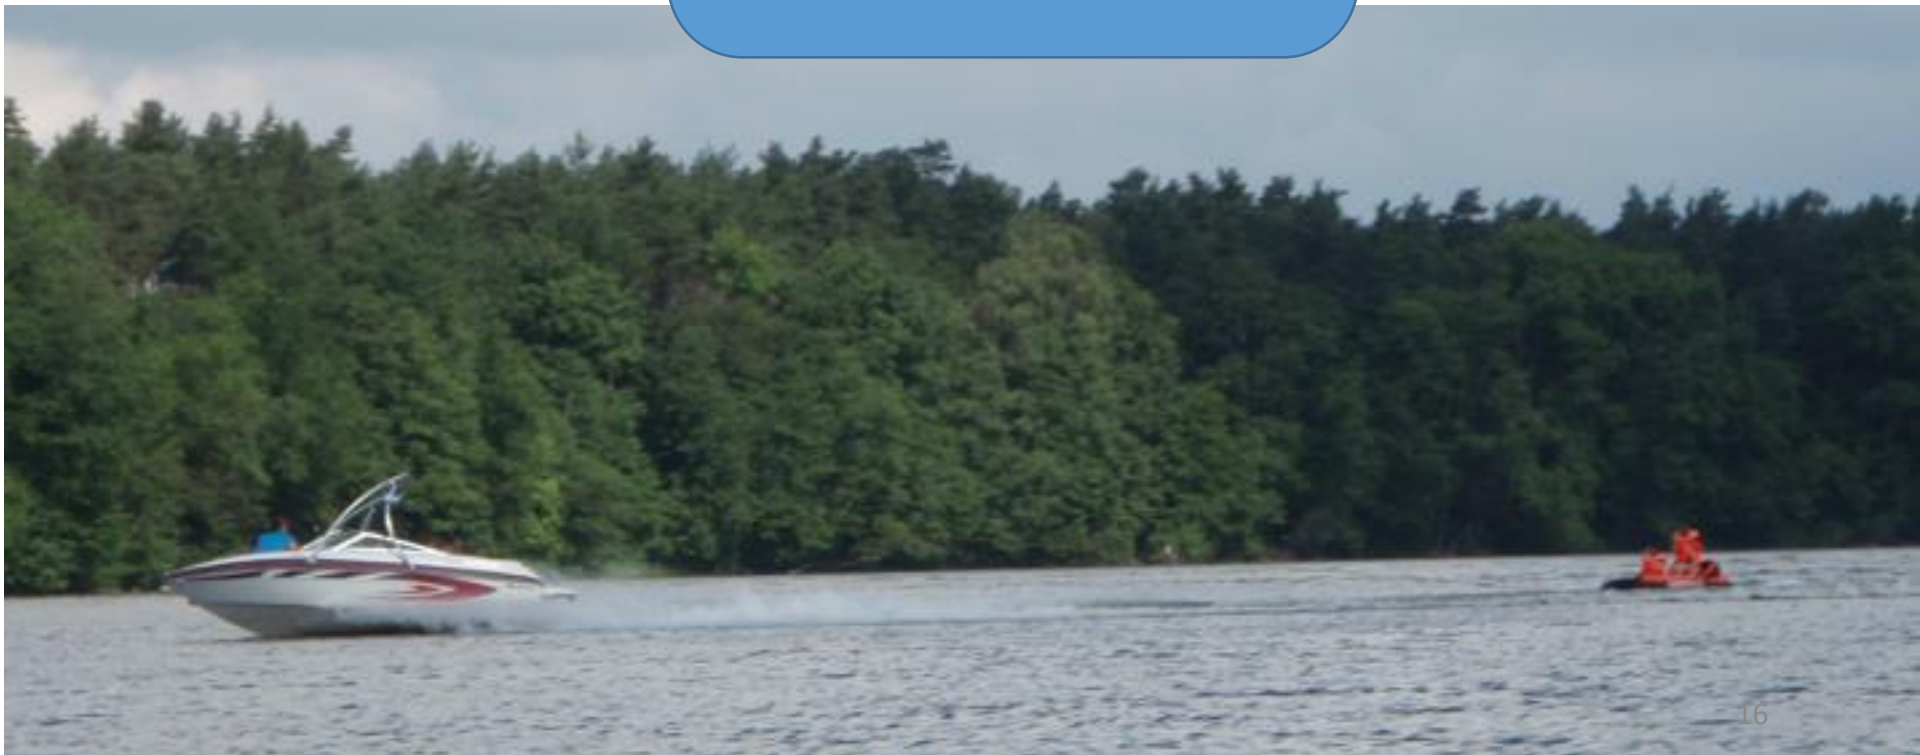
Motorboats wave erosion of
the littoral zone
Swimming

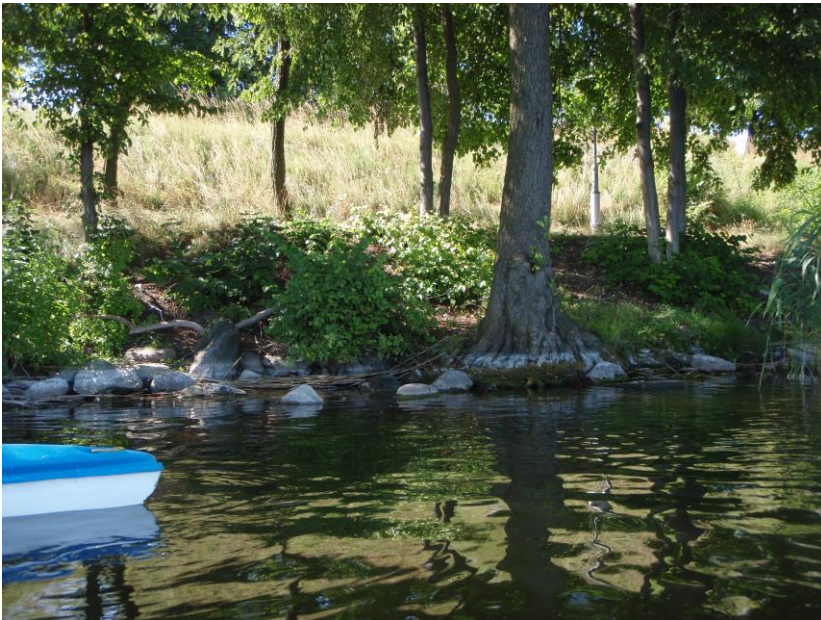
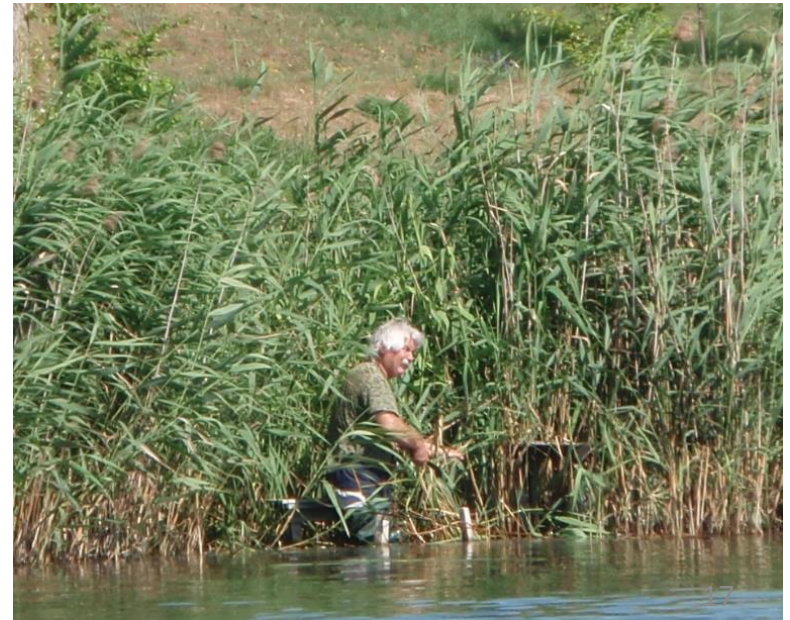
Bait

Bank erosion

Macrophytes gaps $\approx 1 \text{ km} - 920 \text{ m}^2$

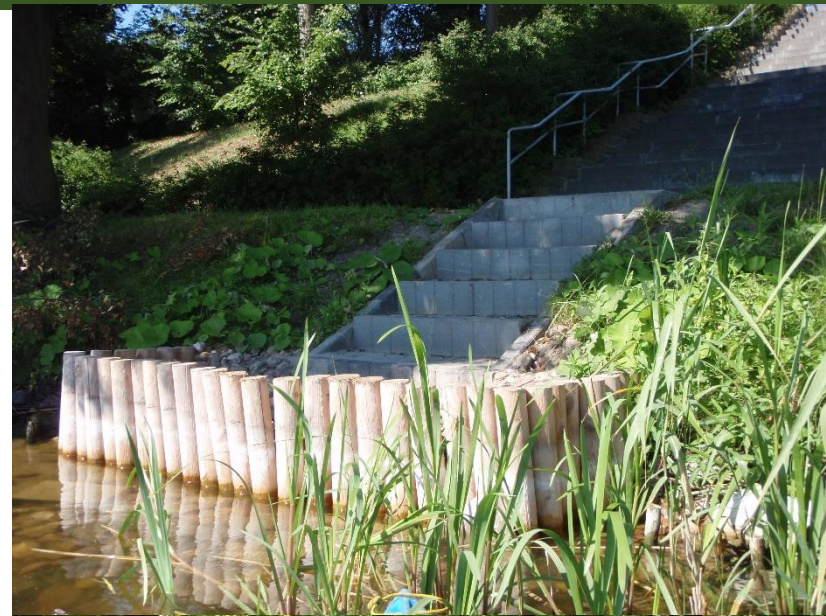
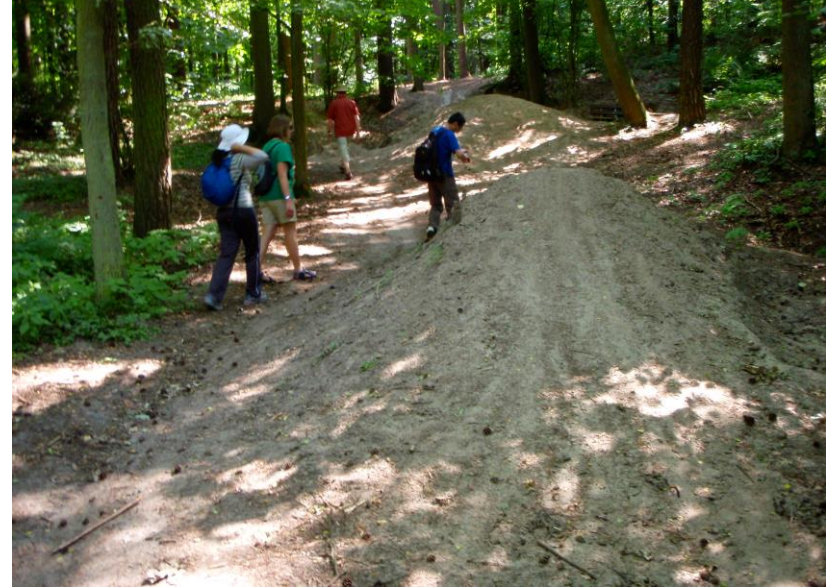
Erosion control measures

- Management of the eroded areas along the shore line;
 - Retention walls
 - Sealed the area for restoration
 - Plantation
- Trail management
 - Regulation of Hiking trails
 - Mountain biking activities

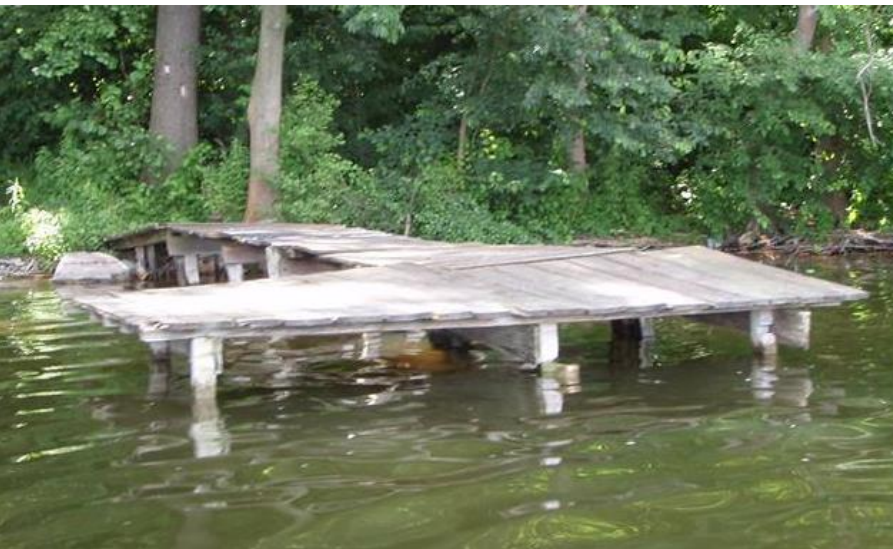
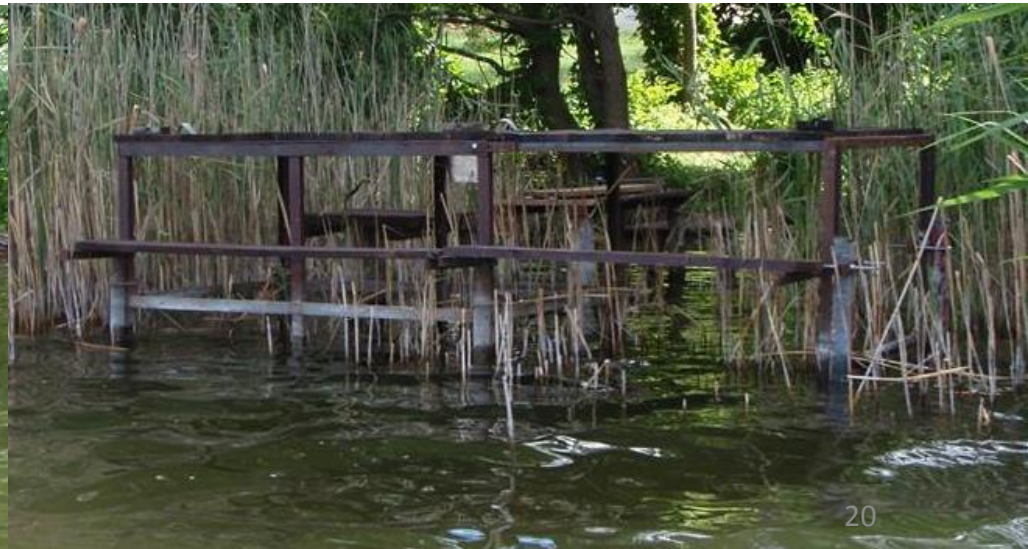
Erosion control measures: fishing docks

- Use of abandoned fishing platform instead of building new ones
- Improved design of fishing platforms
- Selected area around the lake to be used for fishing

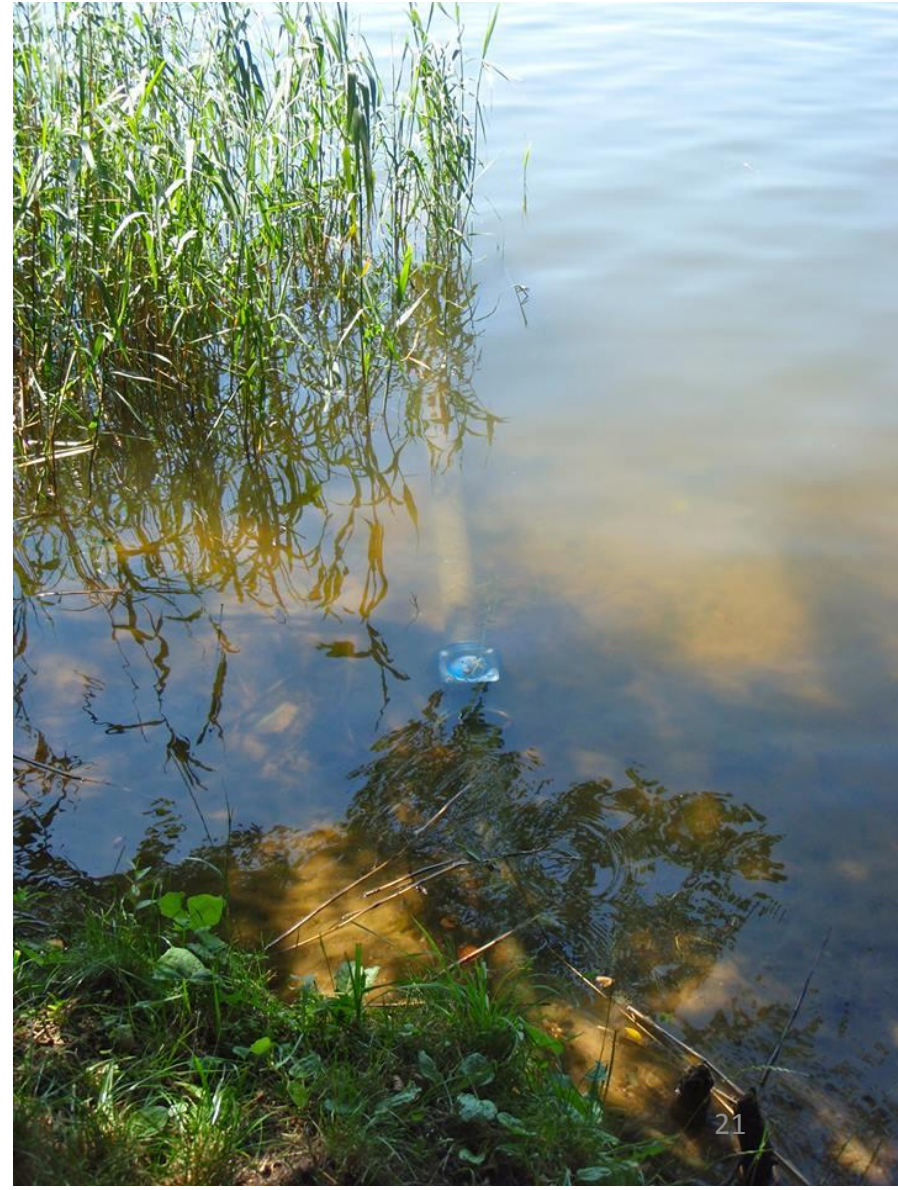
Lake water quality improvement: Withdrawal of water from hypolimnion

- Hypolimnetic withdrawal from the upper lakes for irrigation purposes
