# Macrophytes as a part of Restoration Measurements in Lake Durowskie and an Indicator for water quality

Michał B. Kolasa & Mahmoud Al.Nady

prof. Ryszard Gołdyn

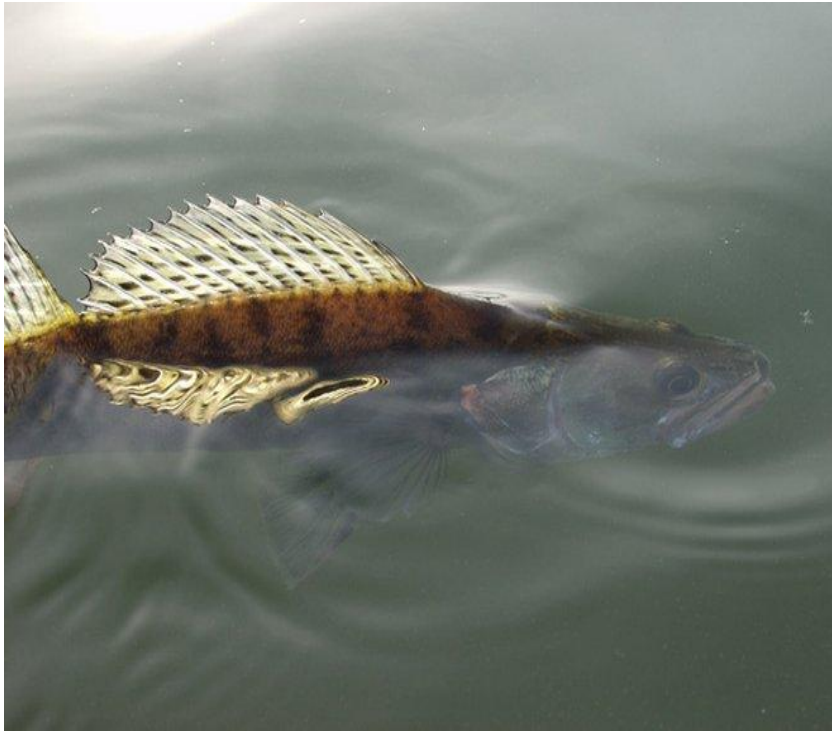
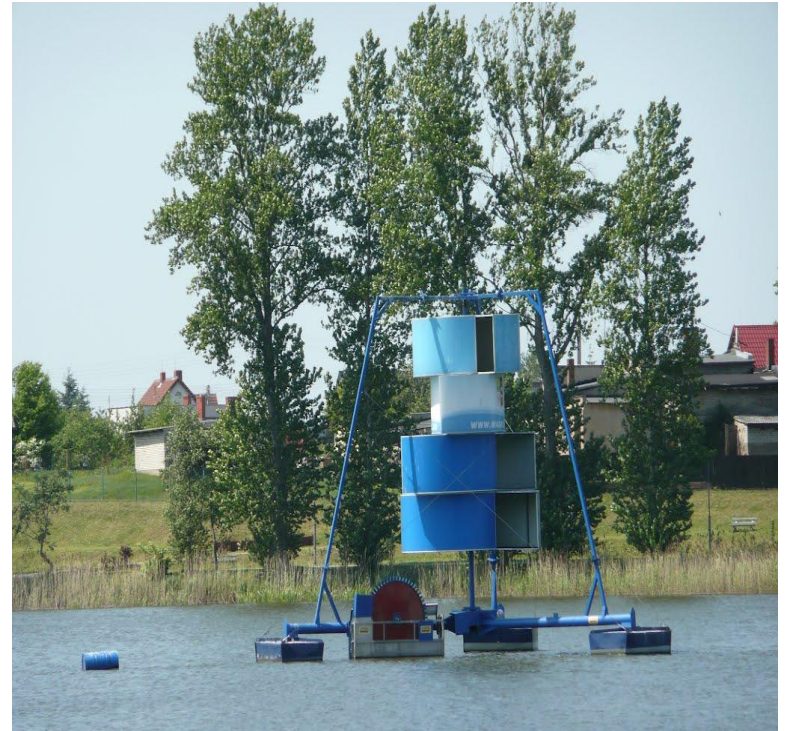
# Introduction...Restoration Program .

Aerator , iron treatment and pike and pikeperch fish introducing

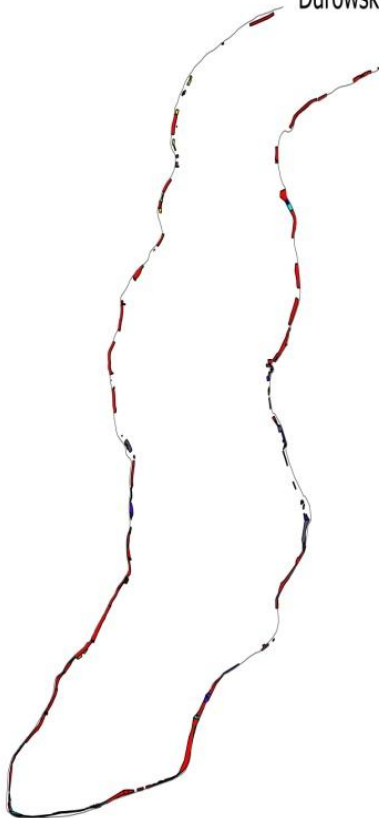
Southern Part of Lake  
Durowskie in scale 1:5000

**Maps of macrophytes associations in the lake . Maps show more coverage in the northern part than the southern part .**

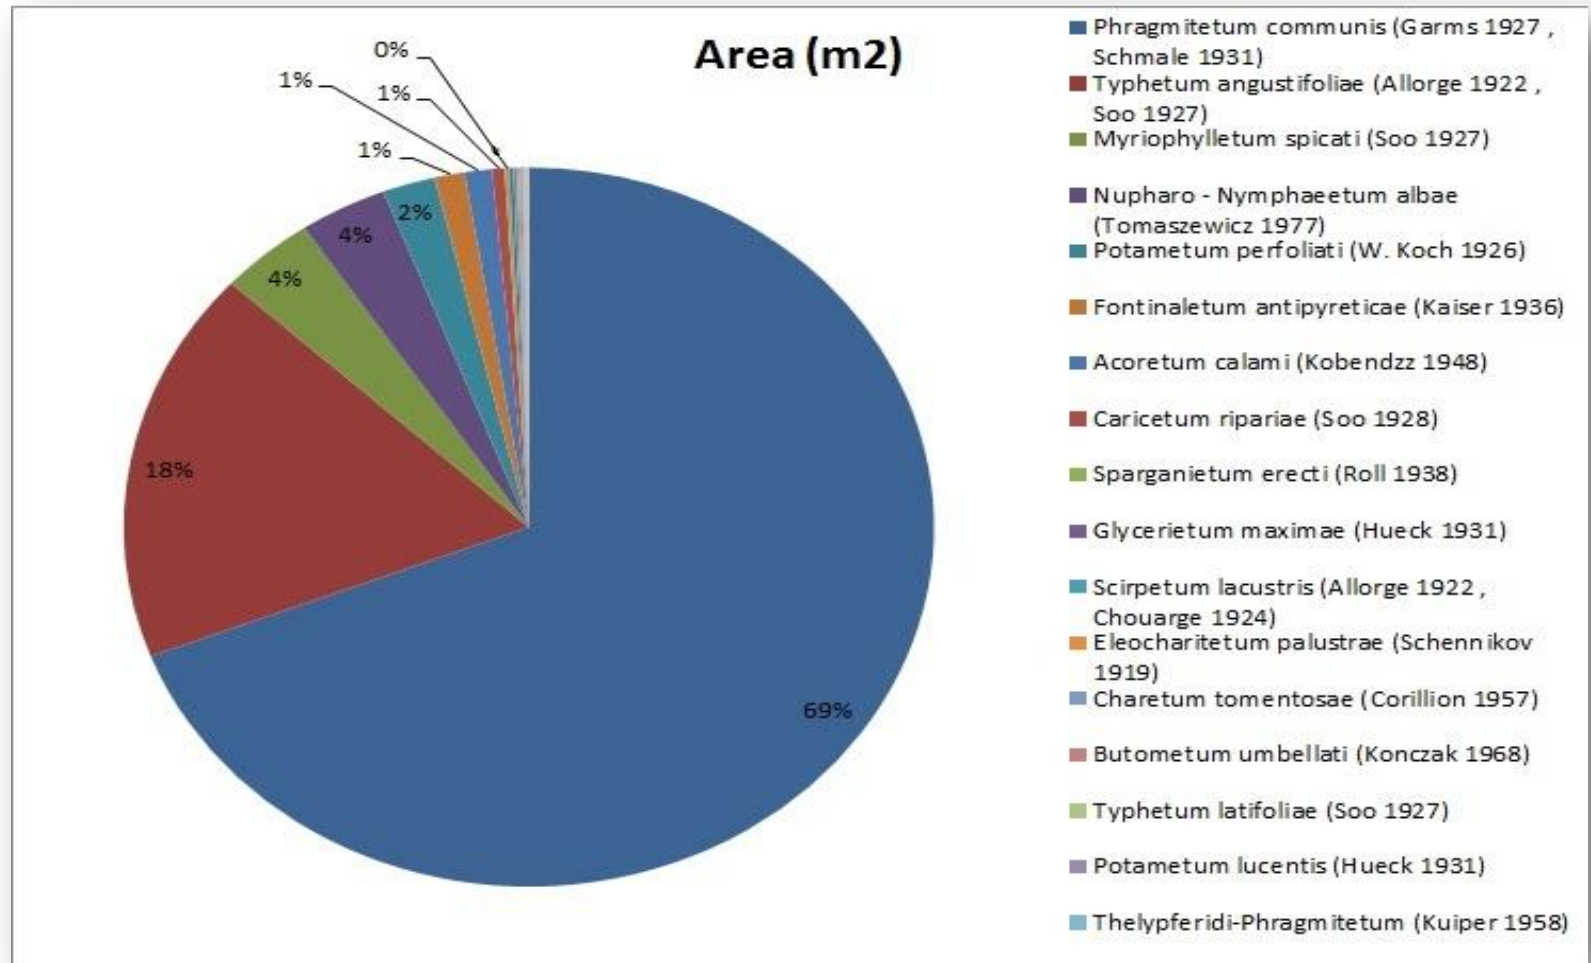
# Results ... Macrophytes distribution (%)

Pie chart for the coverage area expressed in percentage (%).

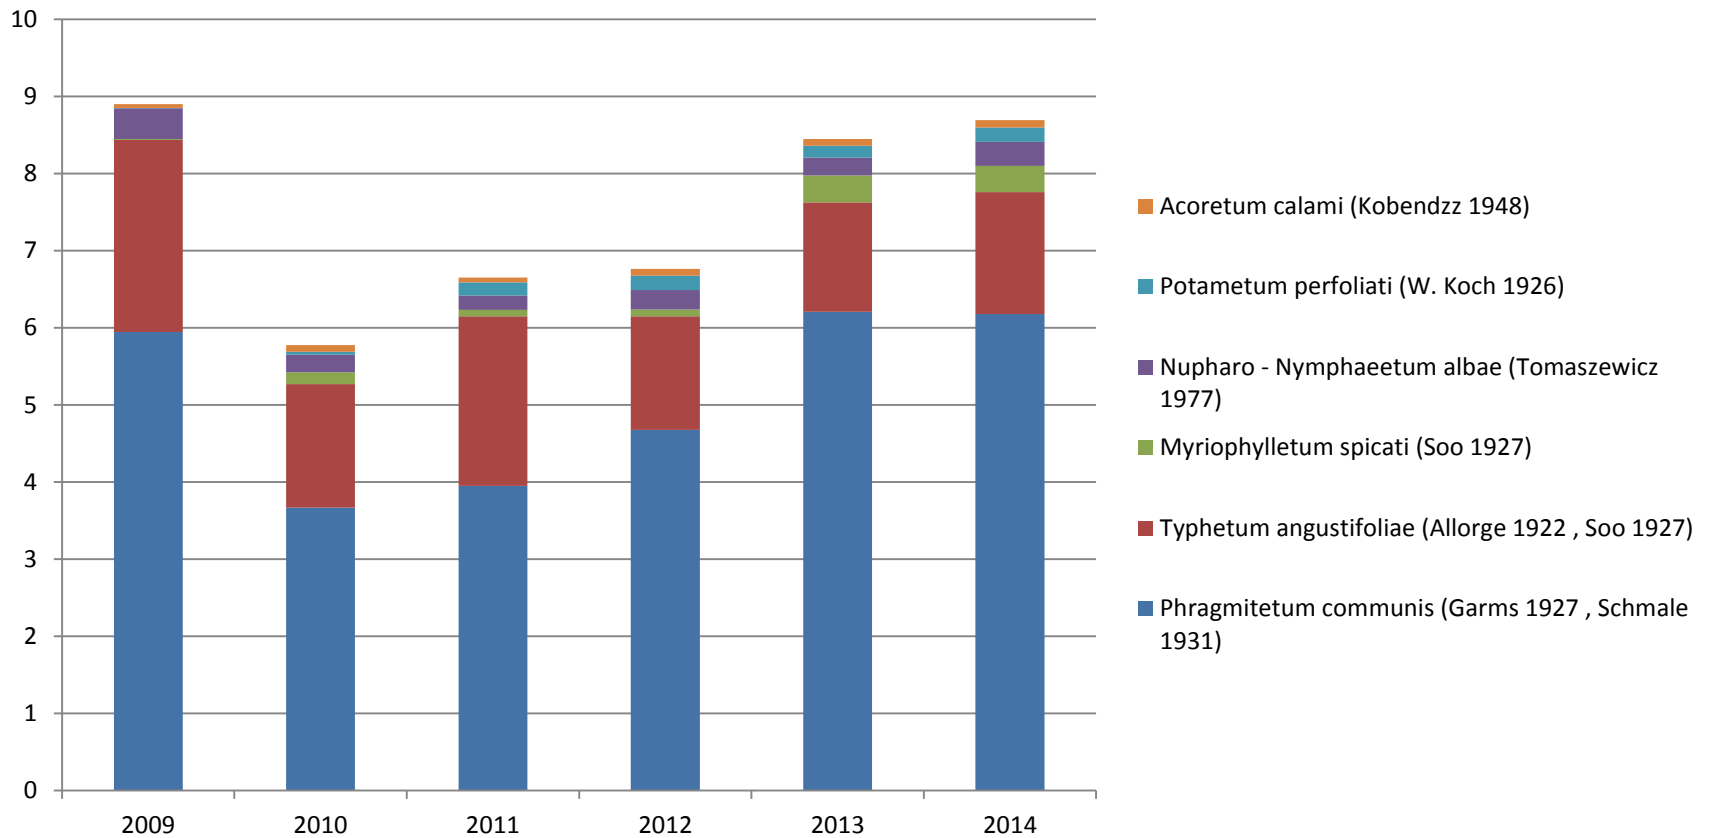
# Results.... Macrophytes associations

Area (ha) of dominant macrophytes

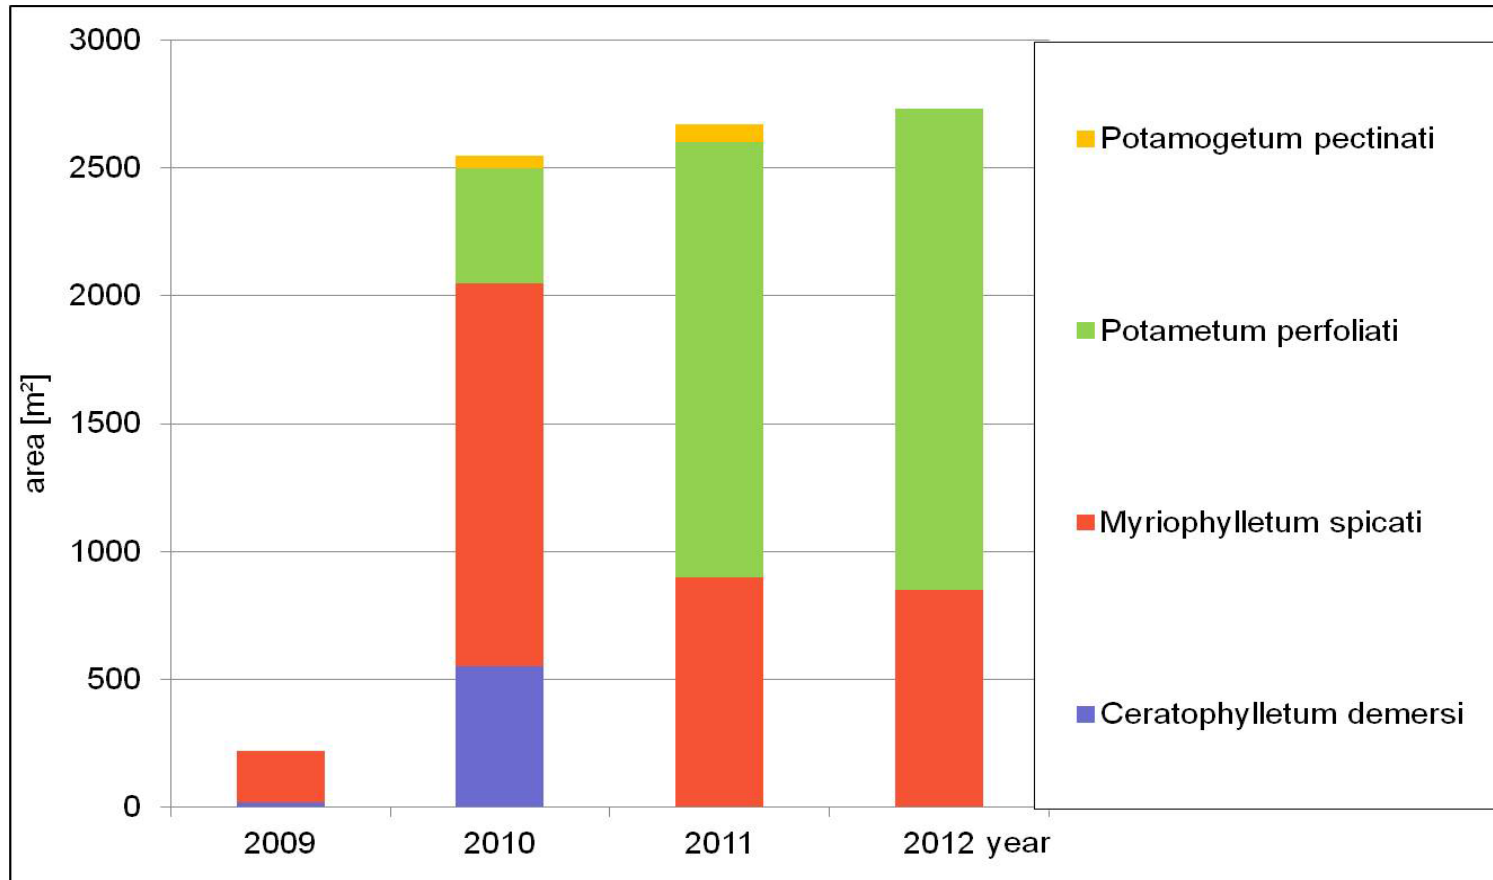
# Results.... Macrophytes associations

Comparing our result with result of 2012 group work . Graph show also composition of submerged association
