# Management of Lake Durowskie

**Summer School 2017**

**'Ecological state of lake during restoration measures'**

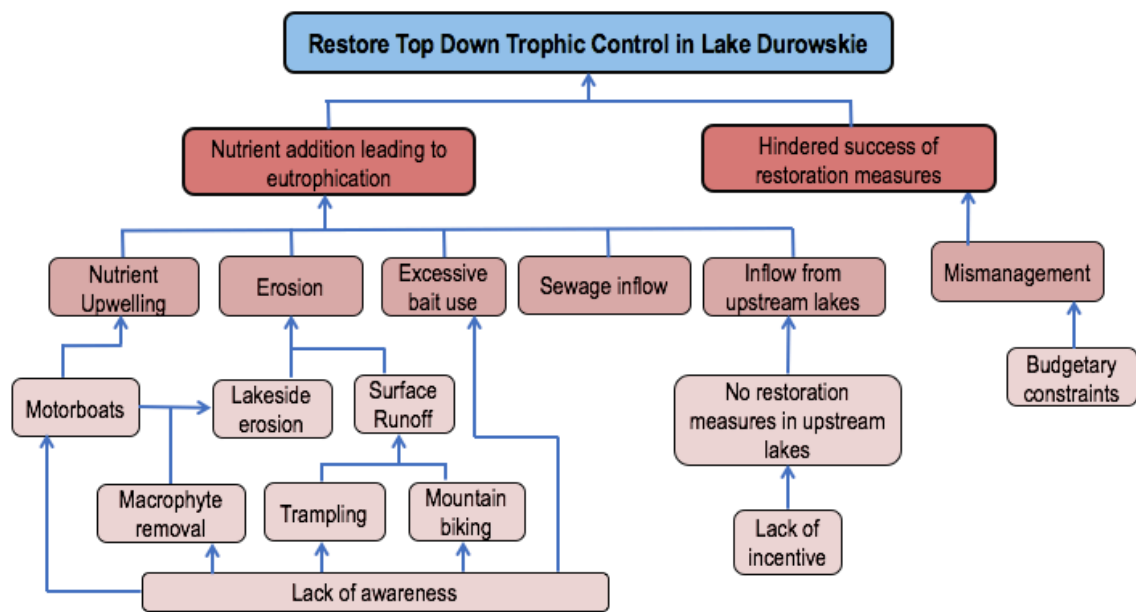
Figure 2. Conceptual model for restoration of Lake Durowskie

The two major pressures faced by the restoration process are the continued addition of nutrients to the lake, and obstacles in the successful implementation of the measures. The major sources of nutrient input are similar to the previous years, and can be read in detail in the previous lake management reports. Management alternatives mentioned later in the report delve deeper into solutions for combatting these threats.

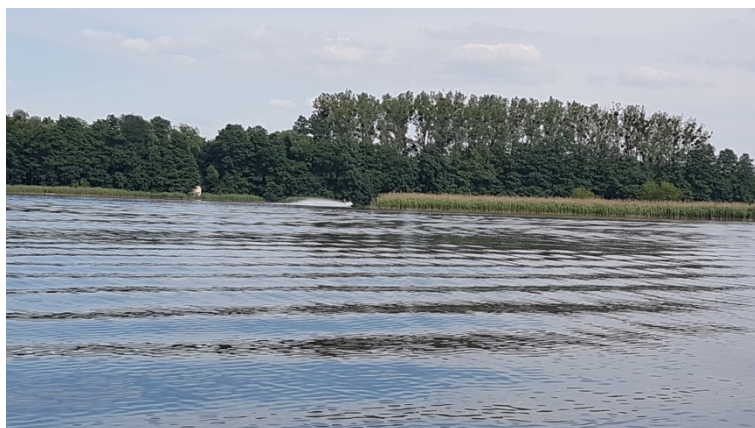
Figure 9. Waves created by motorboats

Waves generated by motor boats (Figure 9) erode the lake’s shoreline, especially in areas lacking in vegetation. The mooring of boats into the macrophyte belt also destroys the vegetation. In addition, they cause disturbance to aquatic ecosystems, damage docks and boats, upset kayakers, paddle boats and row boats, and may endanger swimmers. Motor boats include, but are not limited to: power boats, fishing boats, and jet skis. A few easy to implement measures can used to limit the impact of motorboats and to reduce the pressure on the lake. Figure 8 illustrates how these measures contribute towards the goal.

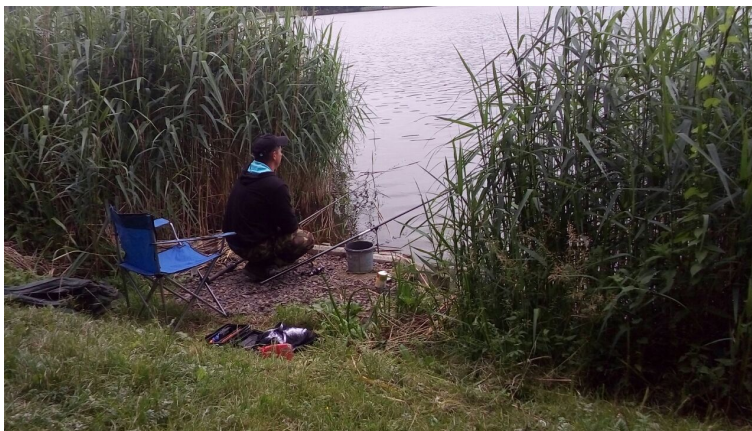
*Figure 11. Patch of macrophyte belt removed for fishing*

Over the last years the number of jetties has been reduced, however many are still constructed behind the macrophyte (reed) belt or without direct access to the lake shore. Such jetties can only be used if the reeds in front of them, or between them and the lake shore, are destroyed to allow access. As mentioned in

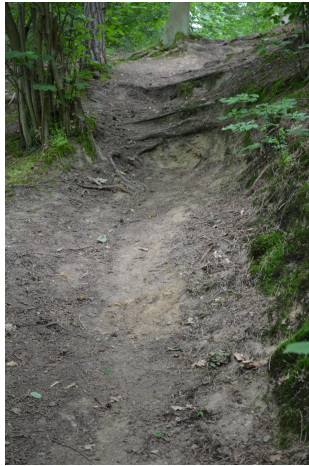
Figure 13. Erosion along walking trails

The access to the lake should become more efficient to prevent people from using unauthorized paths. This can be done by implementing boardwalks, meandering paths, or stairs in strategic locations, like the entrance of the parking lot. All stairs should be posted with signs showing how far ahead the next staircase is located. Informational signs can also be posted informing people about the negative impacts of erosion.

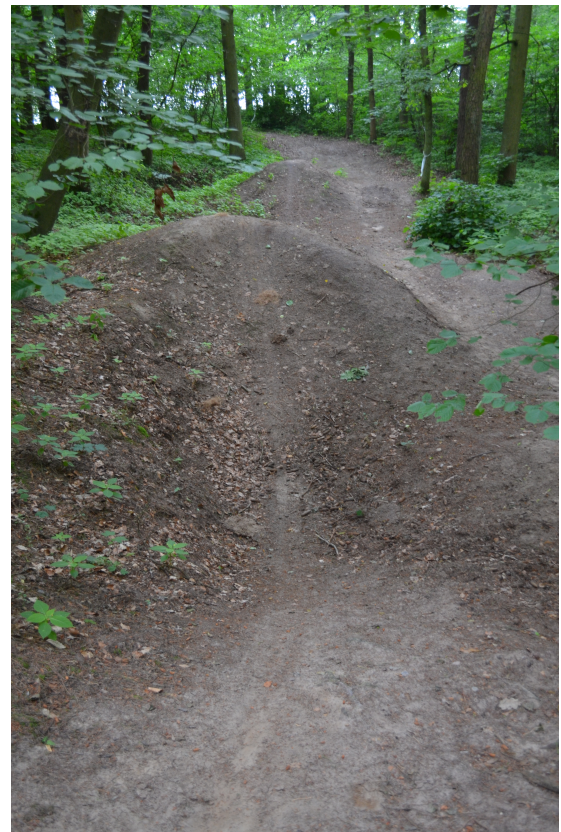
*Figure 15. Trails used for mountain biking. The erosion due to water flow is evident.*

Mountain biking activity in the forested area along the lake also creates pathways for erosion (figure 15). This can be reduced by the measures shown in figure 14.

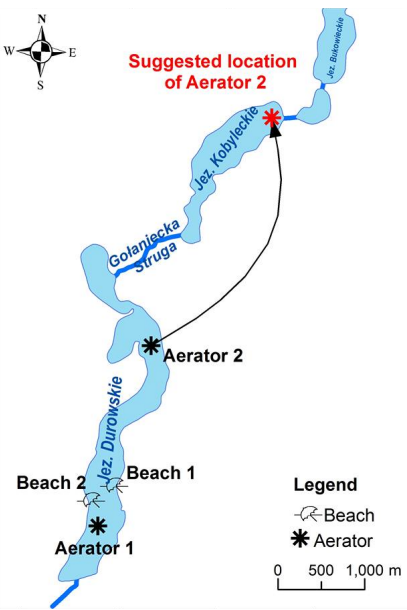
Figure 18. Suggested location of aerator in Lake Kobyleckie

Due to the permanent input of pollutants from Lake Kobyleckie and relatively stronger water quality on the northern side of the lake, we suggest transferring one aerator from the shallow, northern part of the Lake Durowskie to Lake Kobyleckie. The upper lake has a deep area near its

inflow and a shallower area to the south – close to the outflow. Introduction of an aerator to the northern (deep) part of the lake could improve water quality close to the inflow, then to the shallow part, and finally in Lake Durowskie.

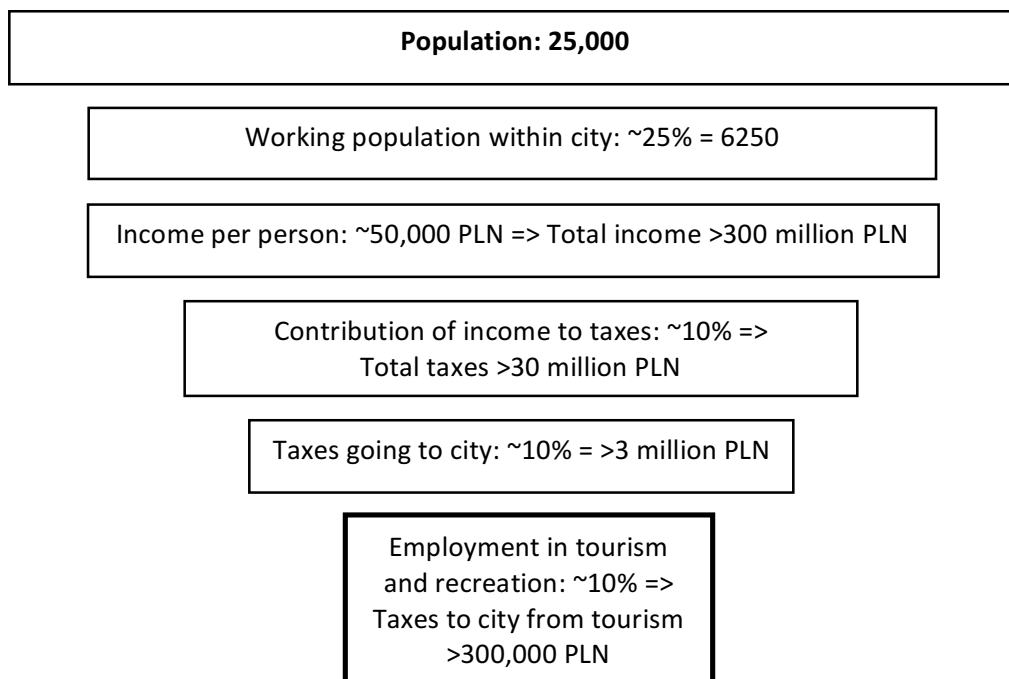
*Figure 19. Estimate for revenue generated from tourism and recreational activities for a hypothetical town. This would be the loss in case the tourism industry is adversely affected by some situation*

To determine the amount of money the city ought to invest in the lake it is necessary to see how much revenue the lake generates for Wągrowiec. We provide here a simple conservative estimation of the tax income generated for the city which would not be present without a healthy lake. (Figure 19)

The population of Wągrowiec is more than 25,000. If we assume that half of those inhabitants are working, and half of those are employed in Wągrowiec, then we have 6,250 people living and working in Wągrowiec. Assuming that these residents make an average of 50,000 PLN per year, they would collectively make over 300 million PLN. We further assume based on estimates previously given by the city administration that at least 10% of these people rely directly on tourism for their livelihoods. If that money were taxed at just 10%, with just 10% of that going to the city, we would estimate the total revenue generated by activities related to the lake would be over 300,000 PLN per year. Given that this far exceeds the approximately 100,000 PLN currently spent on restoration every year it is evident that additional investment in the lake restoration could be financially sound. This provides support for implementing Scenario C.
