# Hydro-macrophytes as biological indicator for ecological assessment and monitoring of Lake Durowskie

# Introduction

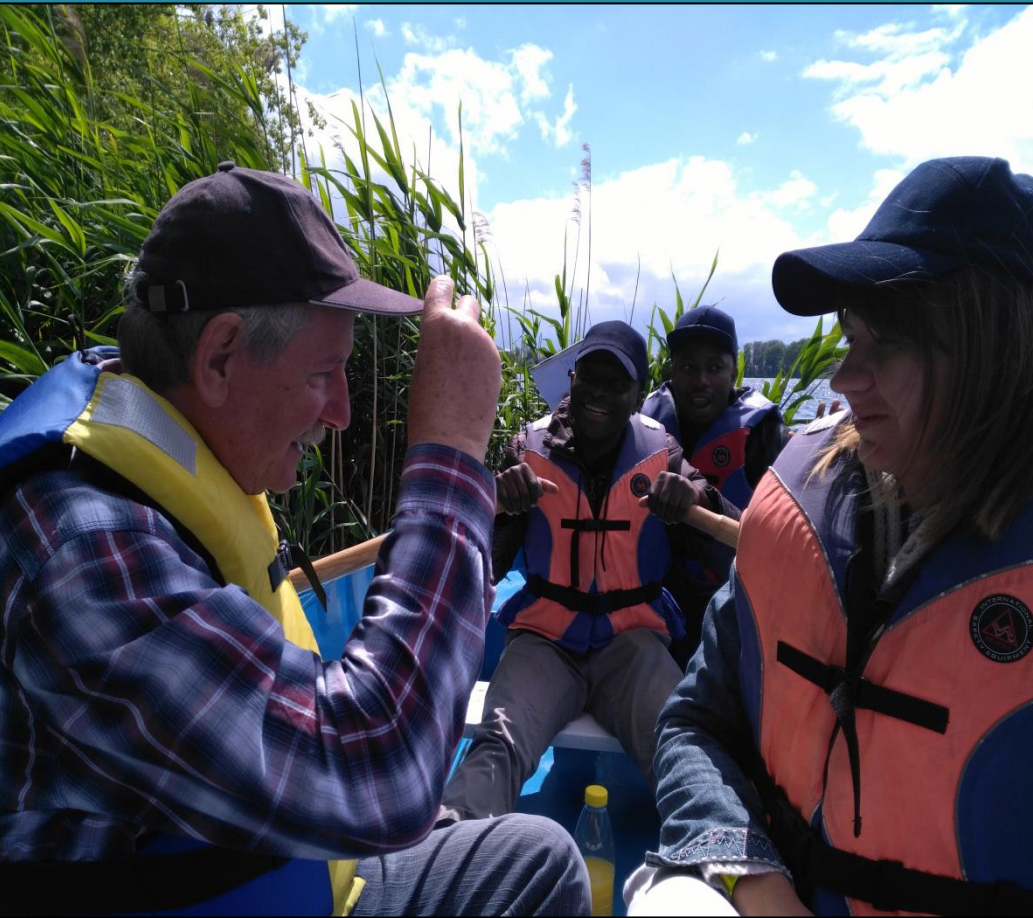
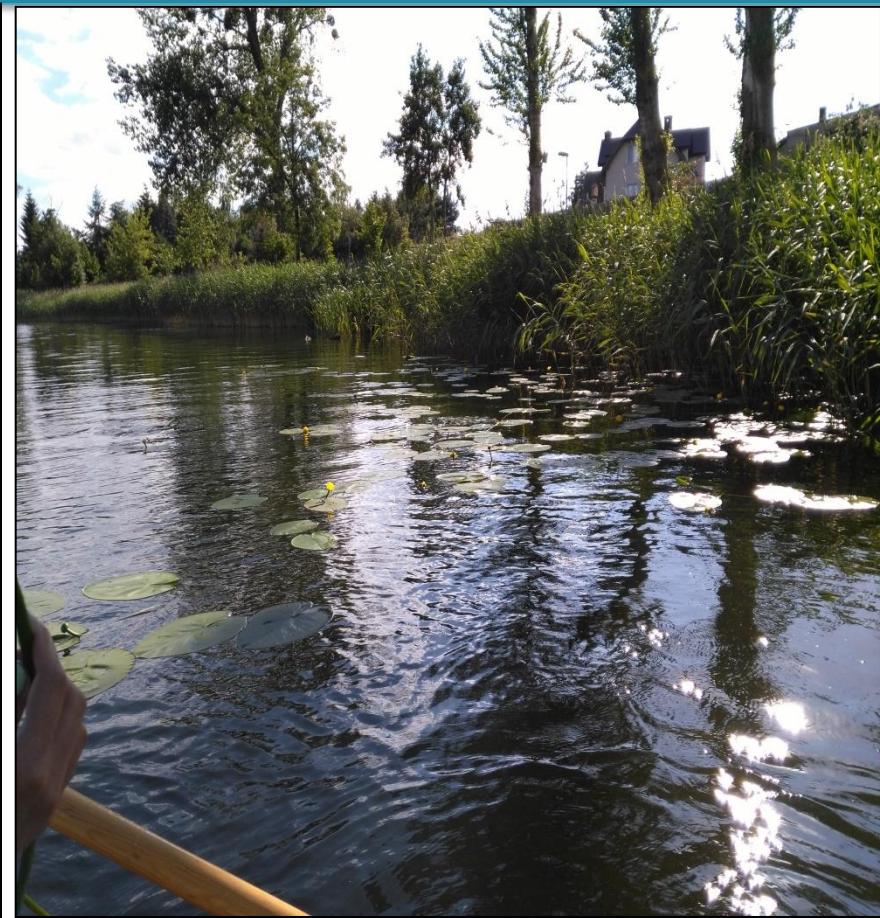
- ❖ **Determination of plant associations of the lake and the outflow.**
- ❖ **Taking coordinates and coverage of plants associations.**
- ❖ **Measuring maximum depth of the presence of macrophytes.**

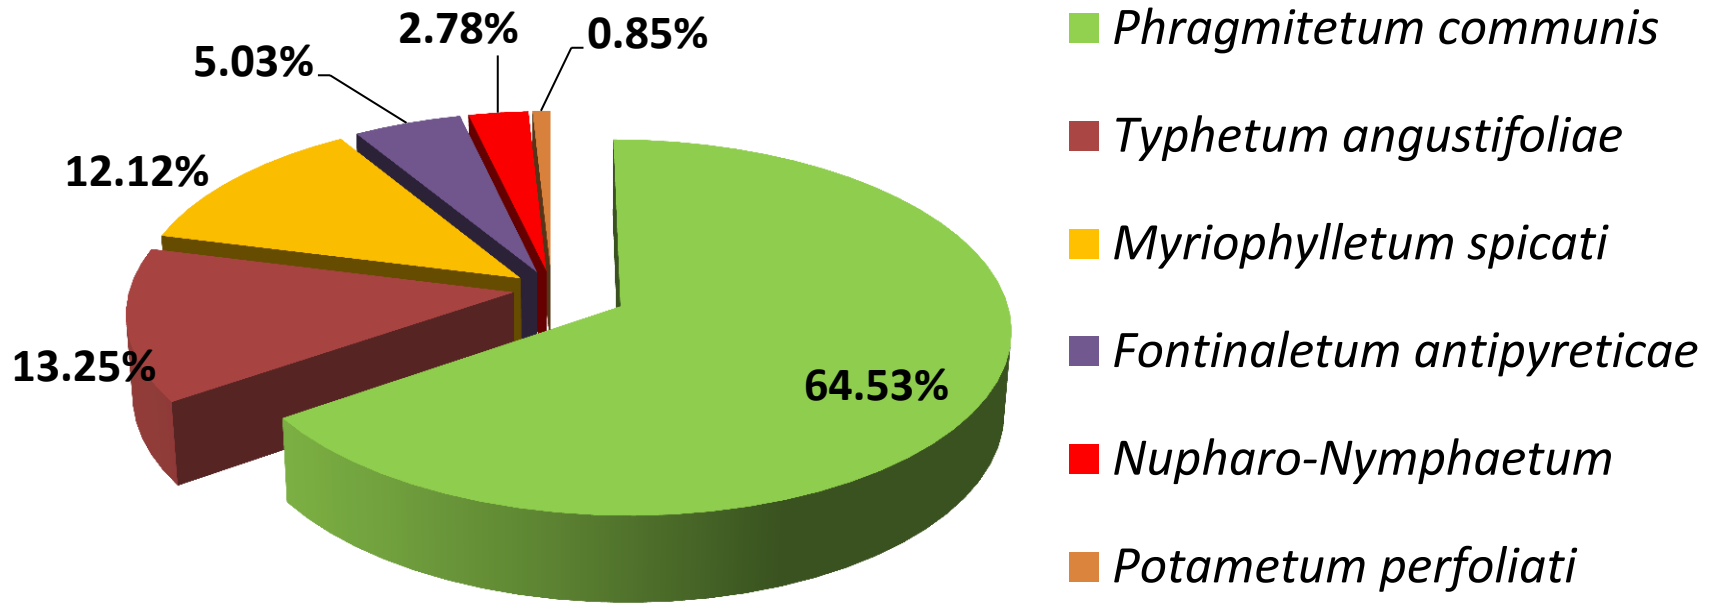
# Dominant associations of macrophytes in percentage coverage

- ❖ Decrease in total coverage area by about **2%** from 2016
- ❖ Submerged plants increased by **23%**
- ❖ *Phragmatitum communis* decreased by **10%**
- ❖ *Myriophylletum spicati* increased by **3.8%**
